(54) **METHOD AND MEANS TO ANALYZE THERMOGRAPHIC DATA ACQUIRED DURING AUTOMATED FIBER PLACEMENT**

(71) Applicant: **United States of America as represented by the Administrator of NASA, Washington, DC (US)**

(57) **ABSTRACT**

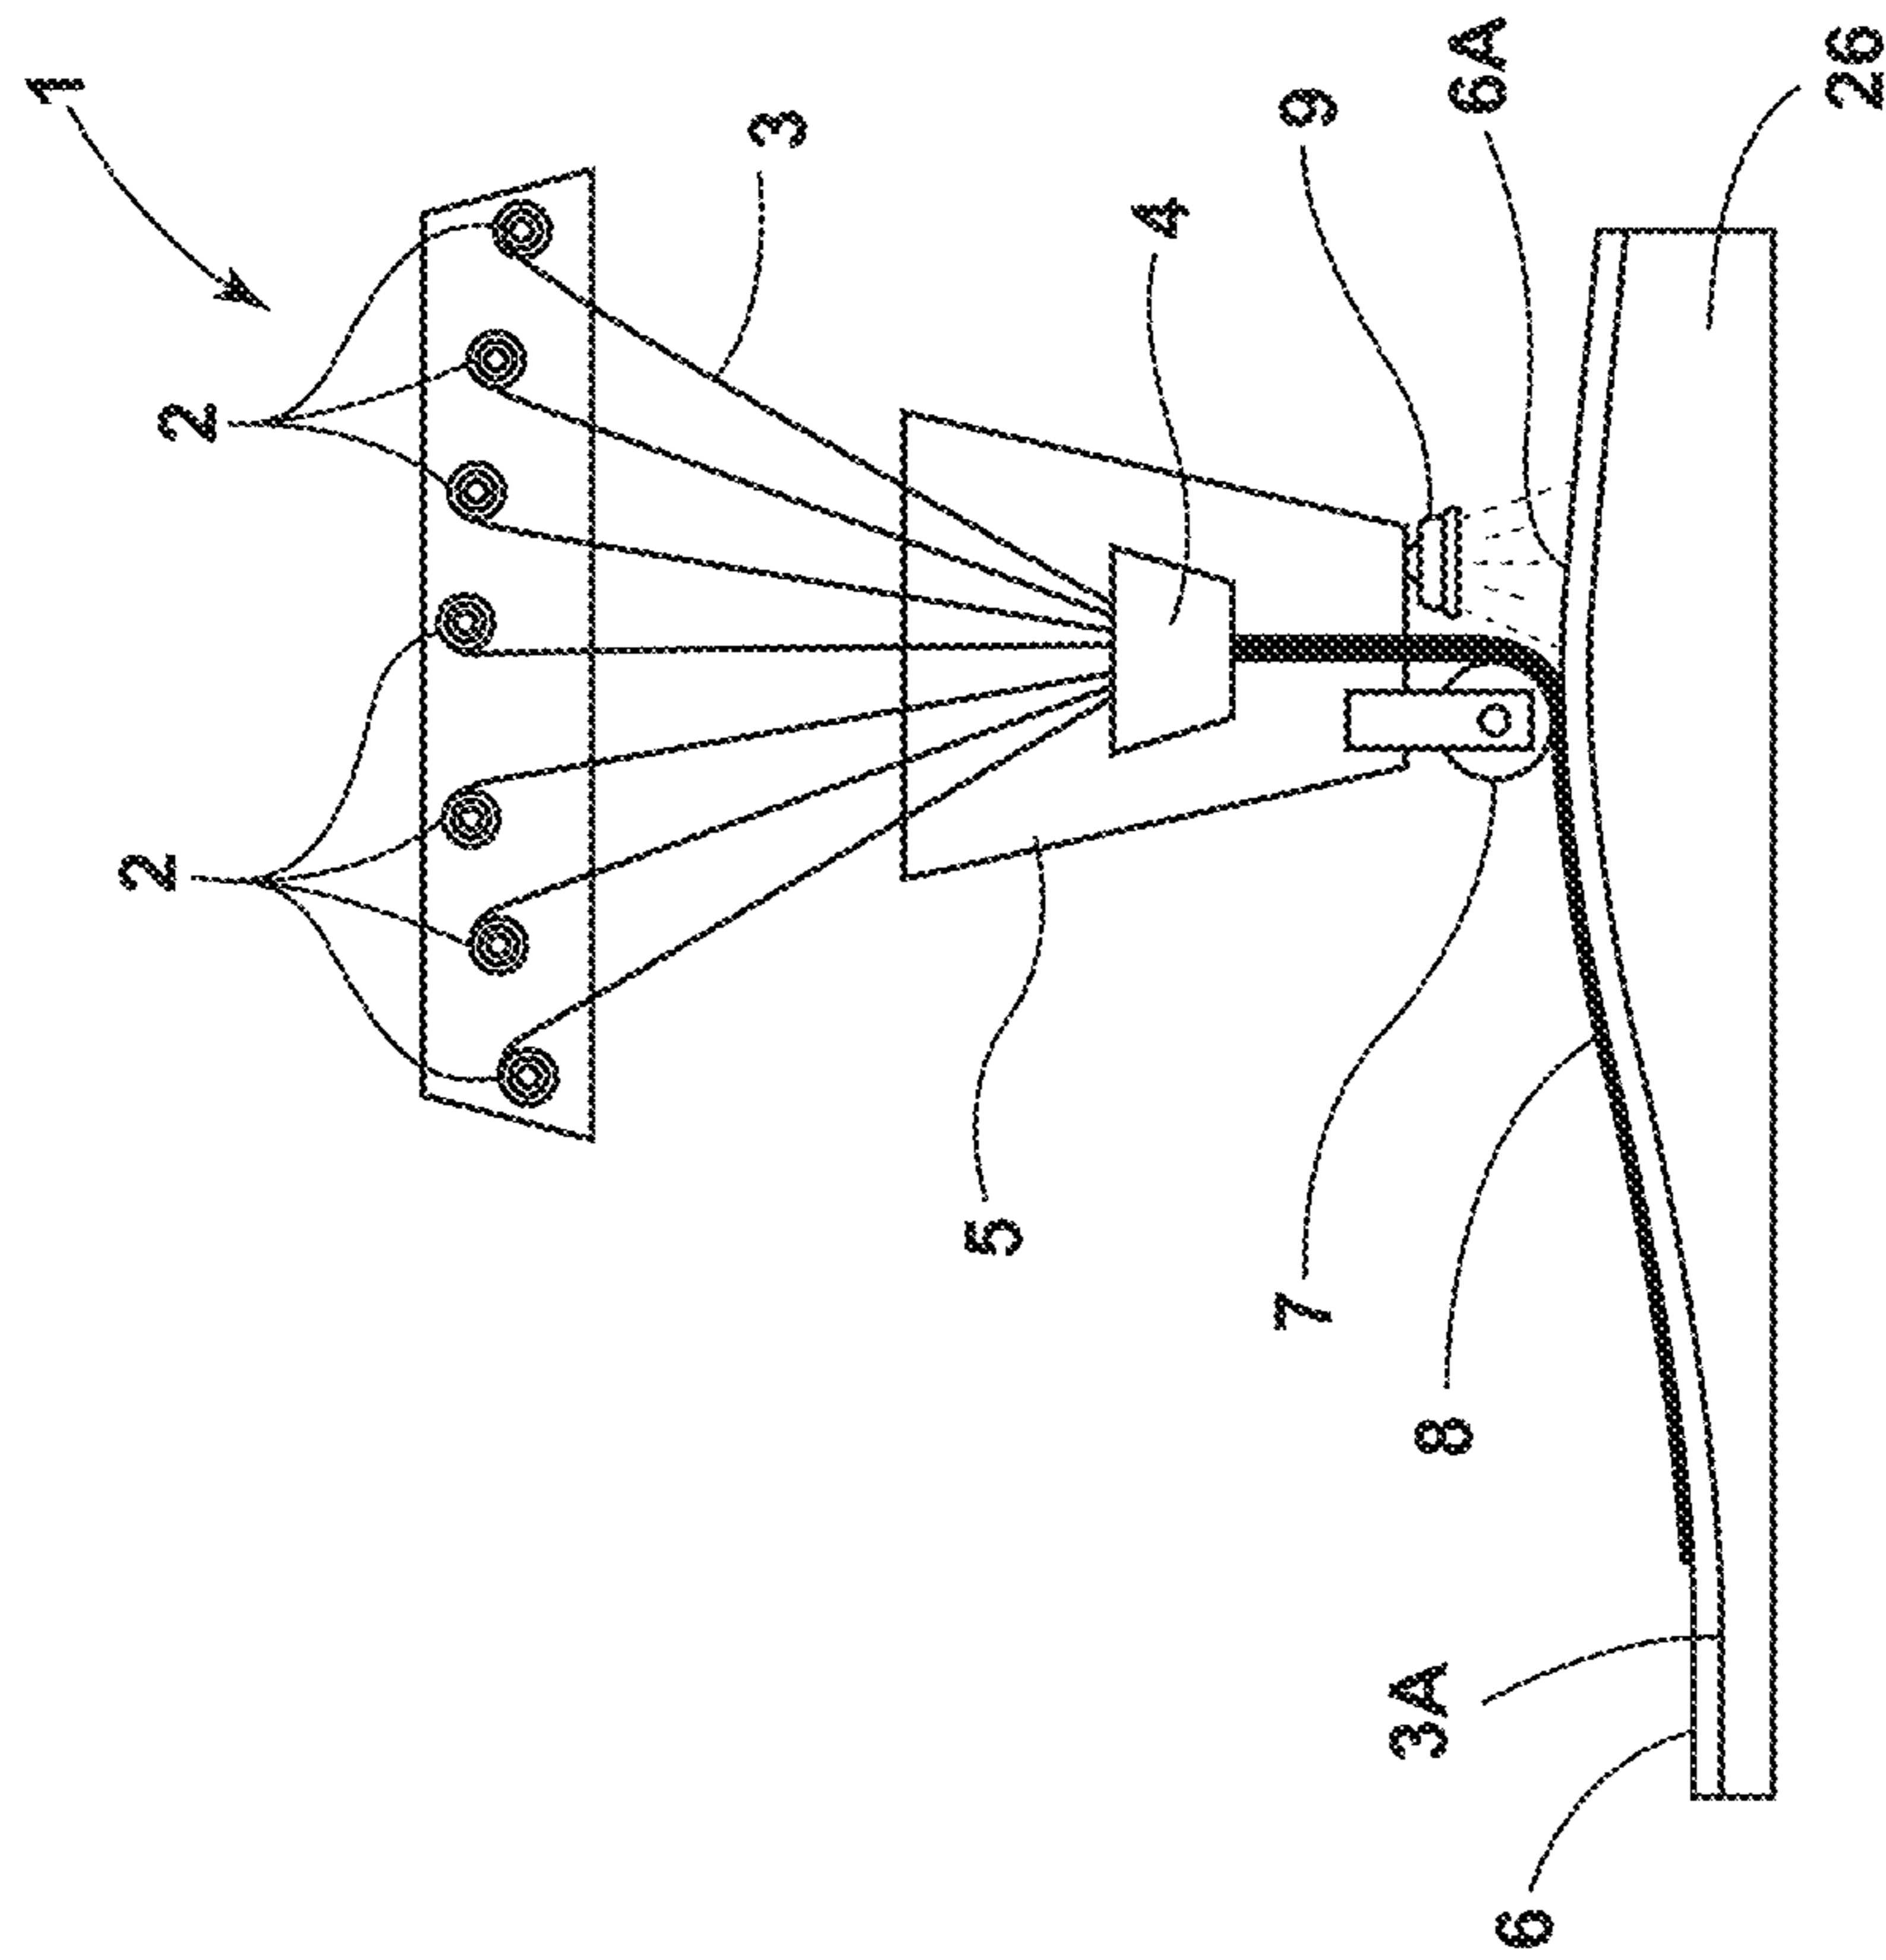
FIG. 1 (PRIOR ART)

With reference to FIG. 1, a known AFP system 1 may include a plurality of spools 2 that feed carbon fiber tape 3 to a collimator 4 of AFP head 5. The AFP head 5 may be mounted on a robotic arm (not shown) that is controlled by a control system to move the head 5 in a predefined manner relative to a substrate 6. An applicator such as a compaction roller 7 compacts and positions a layer of tape 8 onto substrate 6. A heat source such as lamp 9 mounted on AFP head 5 heats a region 6A of substrate 6 before the carbon fiber tape 3 is deposited onto substrate 6. The heating facilitates bonding between the carbon fiber tape 3 that is being applied and the substrate 6. Substrate 6 may comprise layers 3A of carbon fiber tape 3 that have previously been deposited onto a tool 26 corresponding to a surface shape of a finished part that is to be fabricated by the AFP system 1.

FIG. 1 is a schematic view of a prior art automated fiber placement (AFP) device;

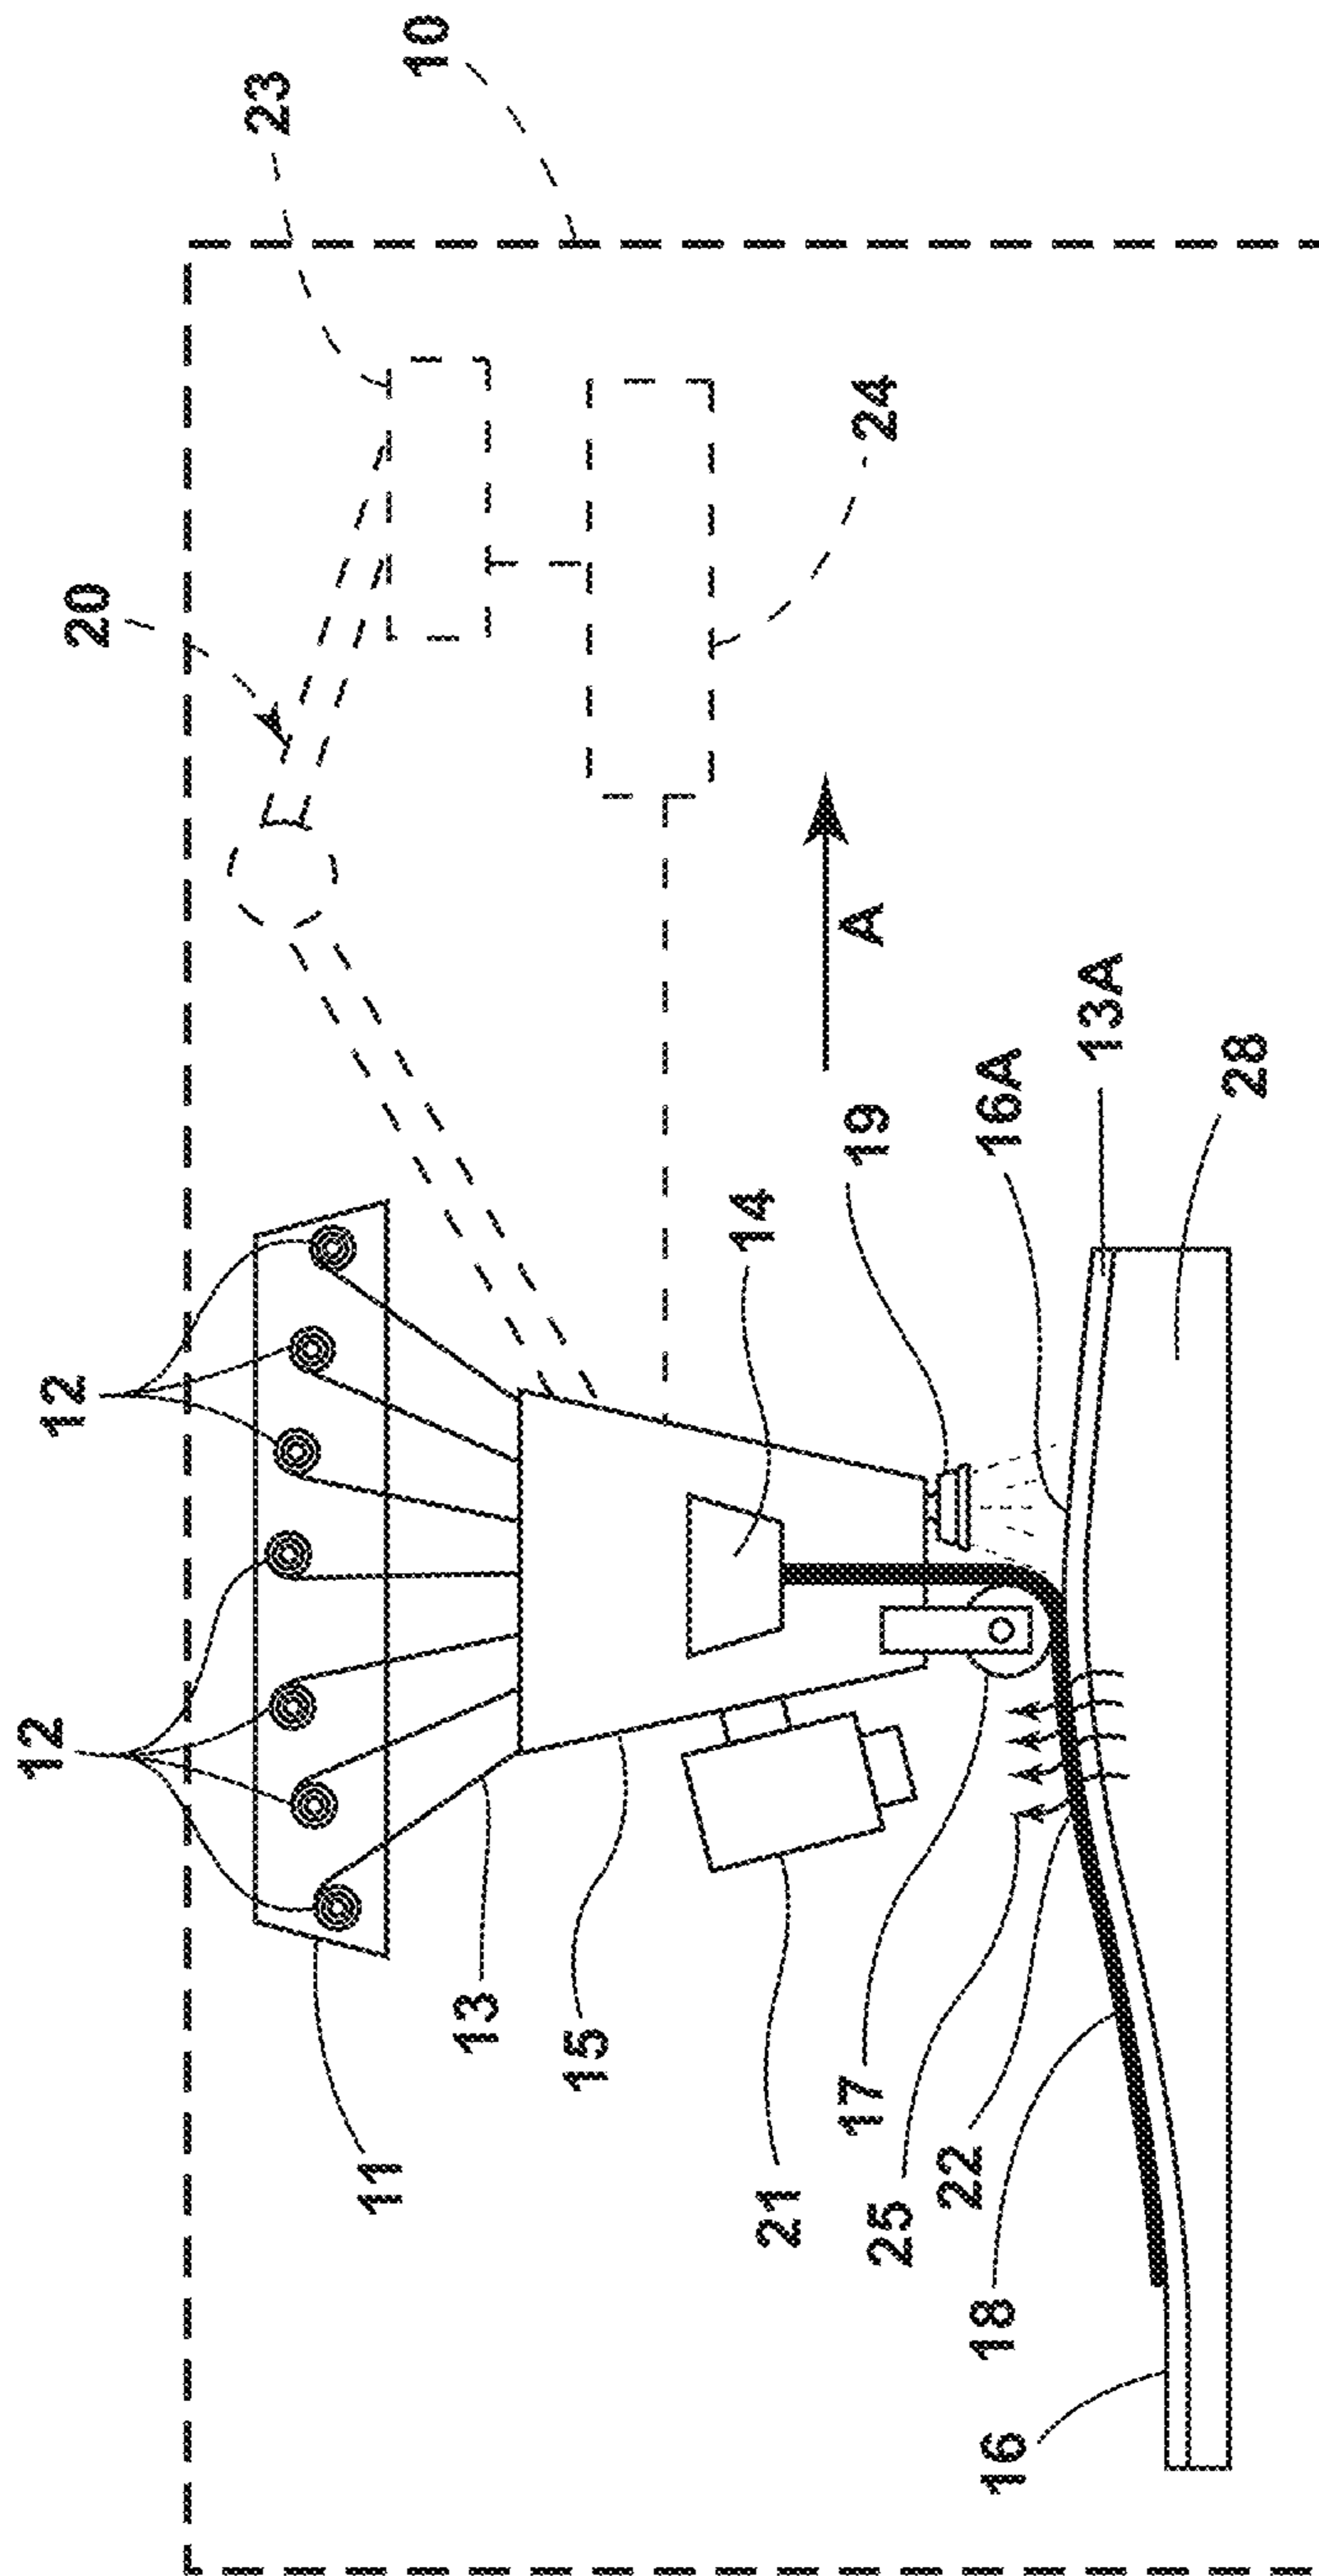
FIG. 2 is a schematic view of an AFP system and infrared camera according to one aspect of the present invention;

With reference to FIG. 2, an automated fiber placement (AFP) system 10 includes a fiber dispensing system 11 that feeds prepreg composite tape 13 to a movable head 15 from spools 12. The tape 13 may comprise prepreg carbon fiber tape or other tape as required for a particular application. The head 15 may include a collimator 14 and applicator such as compaction roller 17 that positions a layer 18 of tape 13 onto a substrate 16 that has been heated by a heat source such as a lamp 19. An infrared (thermal) camera 21 may be mounted to the head 15 to capture thermal image data from surface 22 of layer 18 immediately after the layer 18 is deposited onto heated surface 16A of substrate 16. Thermal camera 21 may comprise an FLIR A65, which uses an uncooled microbolometer sensor to capture 14 bit linear

temperature data in 640×512 resolution at a rate of up to 30 Hz. Camera 21 is powered and communicates with controller 24 via gigabit Ethernet connection using the industry standard GigEVision protocol. Thermal camera 21 may be mounted near an existing visible light camera (not shown), which is used by the operators to monitor the roller 17. The cameras point to a region directly behind the compaction roller 17 to observe the material immediately after lay up as it passes underneath the roller 17. The placement of the camera 21, coupled with an installed 50 mm lens, enable capture of an approximately 3 inch by 4 inch region behind the roller 17, giving a 100 pixel/inch density. Substrate 16 and 16A may comprise prior layers 13A of tape 13 that were positioned in prior passes of head 15. Alternatively, substrate 16 may comprise a surface of a tool 28.

Thermal energy 25 from substrate 16 raises the temperature of surface 22 of layer 18 due to heat transfer from heated surface 16A through layer 18. Camera 21 is positioned to generate thermal images of surface 22 immediately after the composite layer 18 is applied to heated substrate surface 16A by compaction roller 17. As discussed in more detail below, variations in layer 18 and/or substrate 16 result in variations in the temperature of surface 22. These temperature variations may be evaluated to detect and identify defects in layer 18 and/or substrate 16.

The AFP system 10 may include a robotic arm 20 having a base 23. The head 15 is mounted to robotic arm 20, and a controller 24 may be programmed to cause robotic arm 20 to move head 15 relative to substrate 16 along a plurality of predefined paths to thereby position the composite tape according to a predefined design or configuration. During operation, the head 15 may move relative to substrate 16 in the direction of the arrow “A.” The substrate 16 may be stationary relative to robotic arm 20, or the substrate 16 may be movable (e.g., rotatable) relative to the robotic arm 20. The robotic arm 20 comprises a modified industrial robotic arm that is movably mounted on a linear track (not shown) whereby the base 23 of robotic arm 20 travels along a horizontally linear path relative to substrate 16. The robotic arm 20 may comprise an existing robotic arm developed for the Integrated Structural Assembly of Advanced Composites (ISAAC) project. However, it will be understood that various automated fiber placement (AFP) systems have been developed, and the present invention is not limited to a particular AFP device or system.

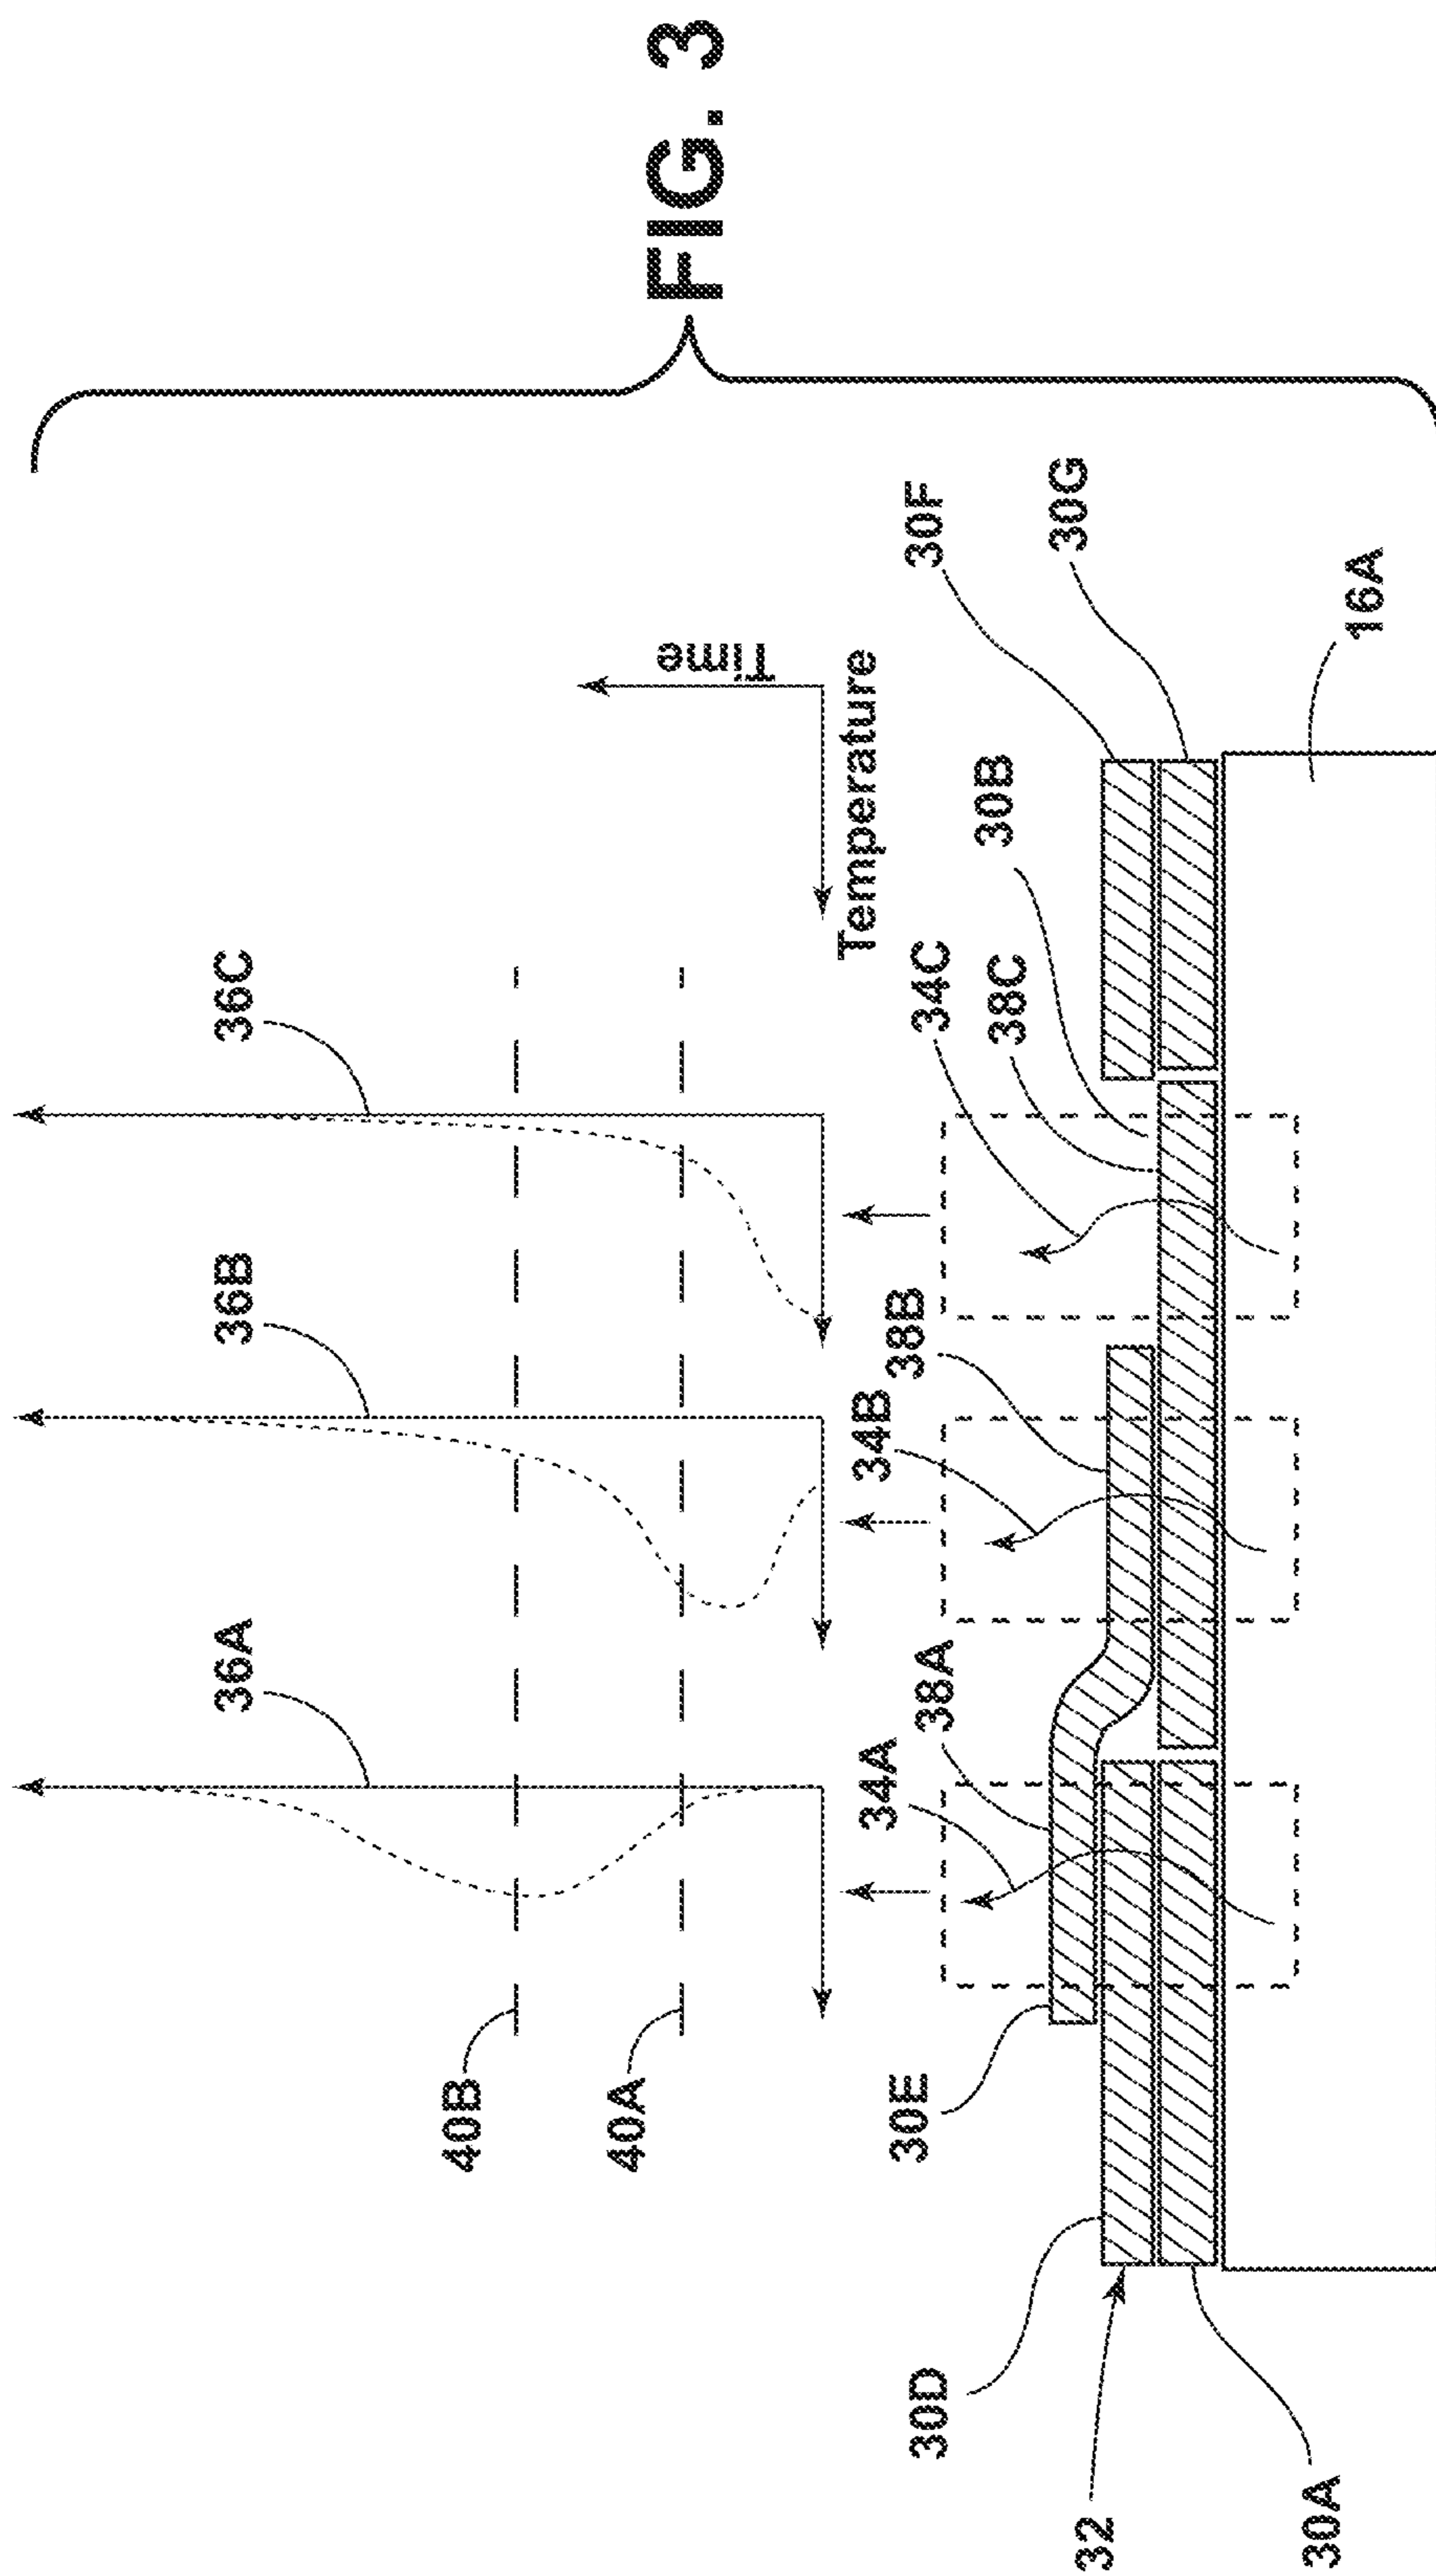
FIG. 3 is a schematic showing heat flow and temperature variations in tow after the tow has been applied to a heated substrate;

Two methods of thermography inspection may be used for in situ evaluation. One method involves observing the surface of a new ply layer as it is placed over a pre-heated substrate. FIG. 3 shows simplified examples of signals that

would be expected for an ideal (defect-free) layup, wherein heat is conducted upward from the heated substrate. Laps, over lapping tows, or tows with poor adhesion are typically colder because the material is thicker. Gaps are typically hotter because the camera “sees” the heated substrate. Also, after plies are placed, the AFP robot may be used as a moving heat source and camera to perform a line scan. To perform a thermographic line scan, the surface of the laminate is heated, and the heat diffusion is observed (captured with a thermal camera). A post layup scan process has been used to inspect post cure composite panels (see W. P. Winfree, D. M. Heath, and K. E. Cramer, “Thermal diffusivity imaging with a moving line source,” in *Thermosense XXIII*, vol. 4360, 2001, pp. 606-615).

Prepreg tow strips **30A-30C** (FIG. 3) may be deposited on a heated substrate **16A**, and one or more additional prepreg tow strips **30D-30F** may be positioned on (over) the lower prepreg tow strips **30A-30C** in various configurations as required for a particular layup of a composite structure **32**. Heat flows from heated substrate **16A** as shown by arrows **34A-34C**. Graphs **36A-36C** correspond to heat arrows **34A-34C**, respectively, and show temperature as a function of time. As shown by graphs **36A-36C**, temperature at surfaces **38A-38C** will typically rise as the heat flows from heated substrate **16A** to the surfaces **38A-38C**, and the surfaces **38A-38C** will then begin to cool. In the illustrated example, surface **38A** has a delayed temperature peak due to the increased thickness resulting from three layers **30A**, **30D**, and **30E** of tow below surface **38A**. Surface **38C** reaches a temperature peak more quickly because the surface **38C** corresponds to a single layer **30B** of tow tape between surface **38C** and heated substrate **16A**. Surface **38B** corresponds to two layers **30E** and **30B** of prepreg tow, and the temperature of surface **38B** therefore reaches a peak at a time that is between the time at which the peak temperature occurs for surfaces **38A** and **38C**. It will be understood that FIG. 3 is schematic in nature, and generally shows temperature and heat transfer characteristics that may be associated with different tow layups. However, the heat versus time profile for a given composite structure and layup may vary from the examples of FIG. 3.

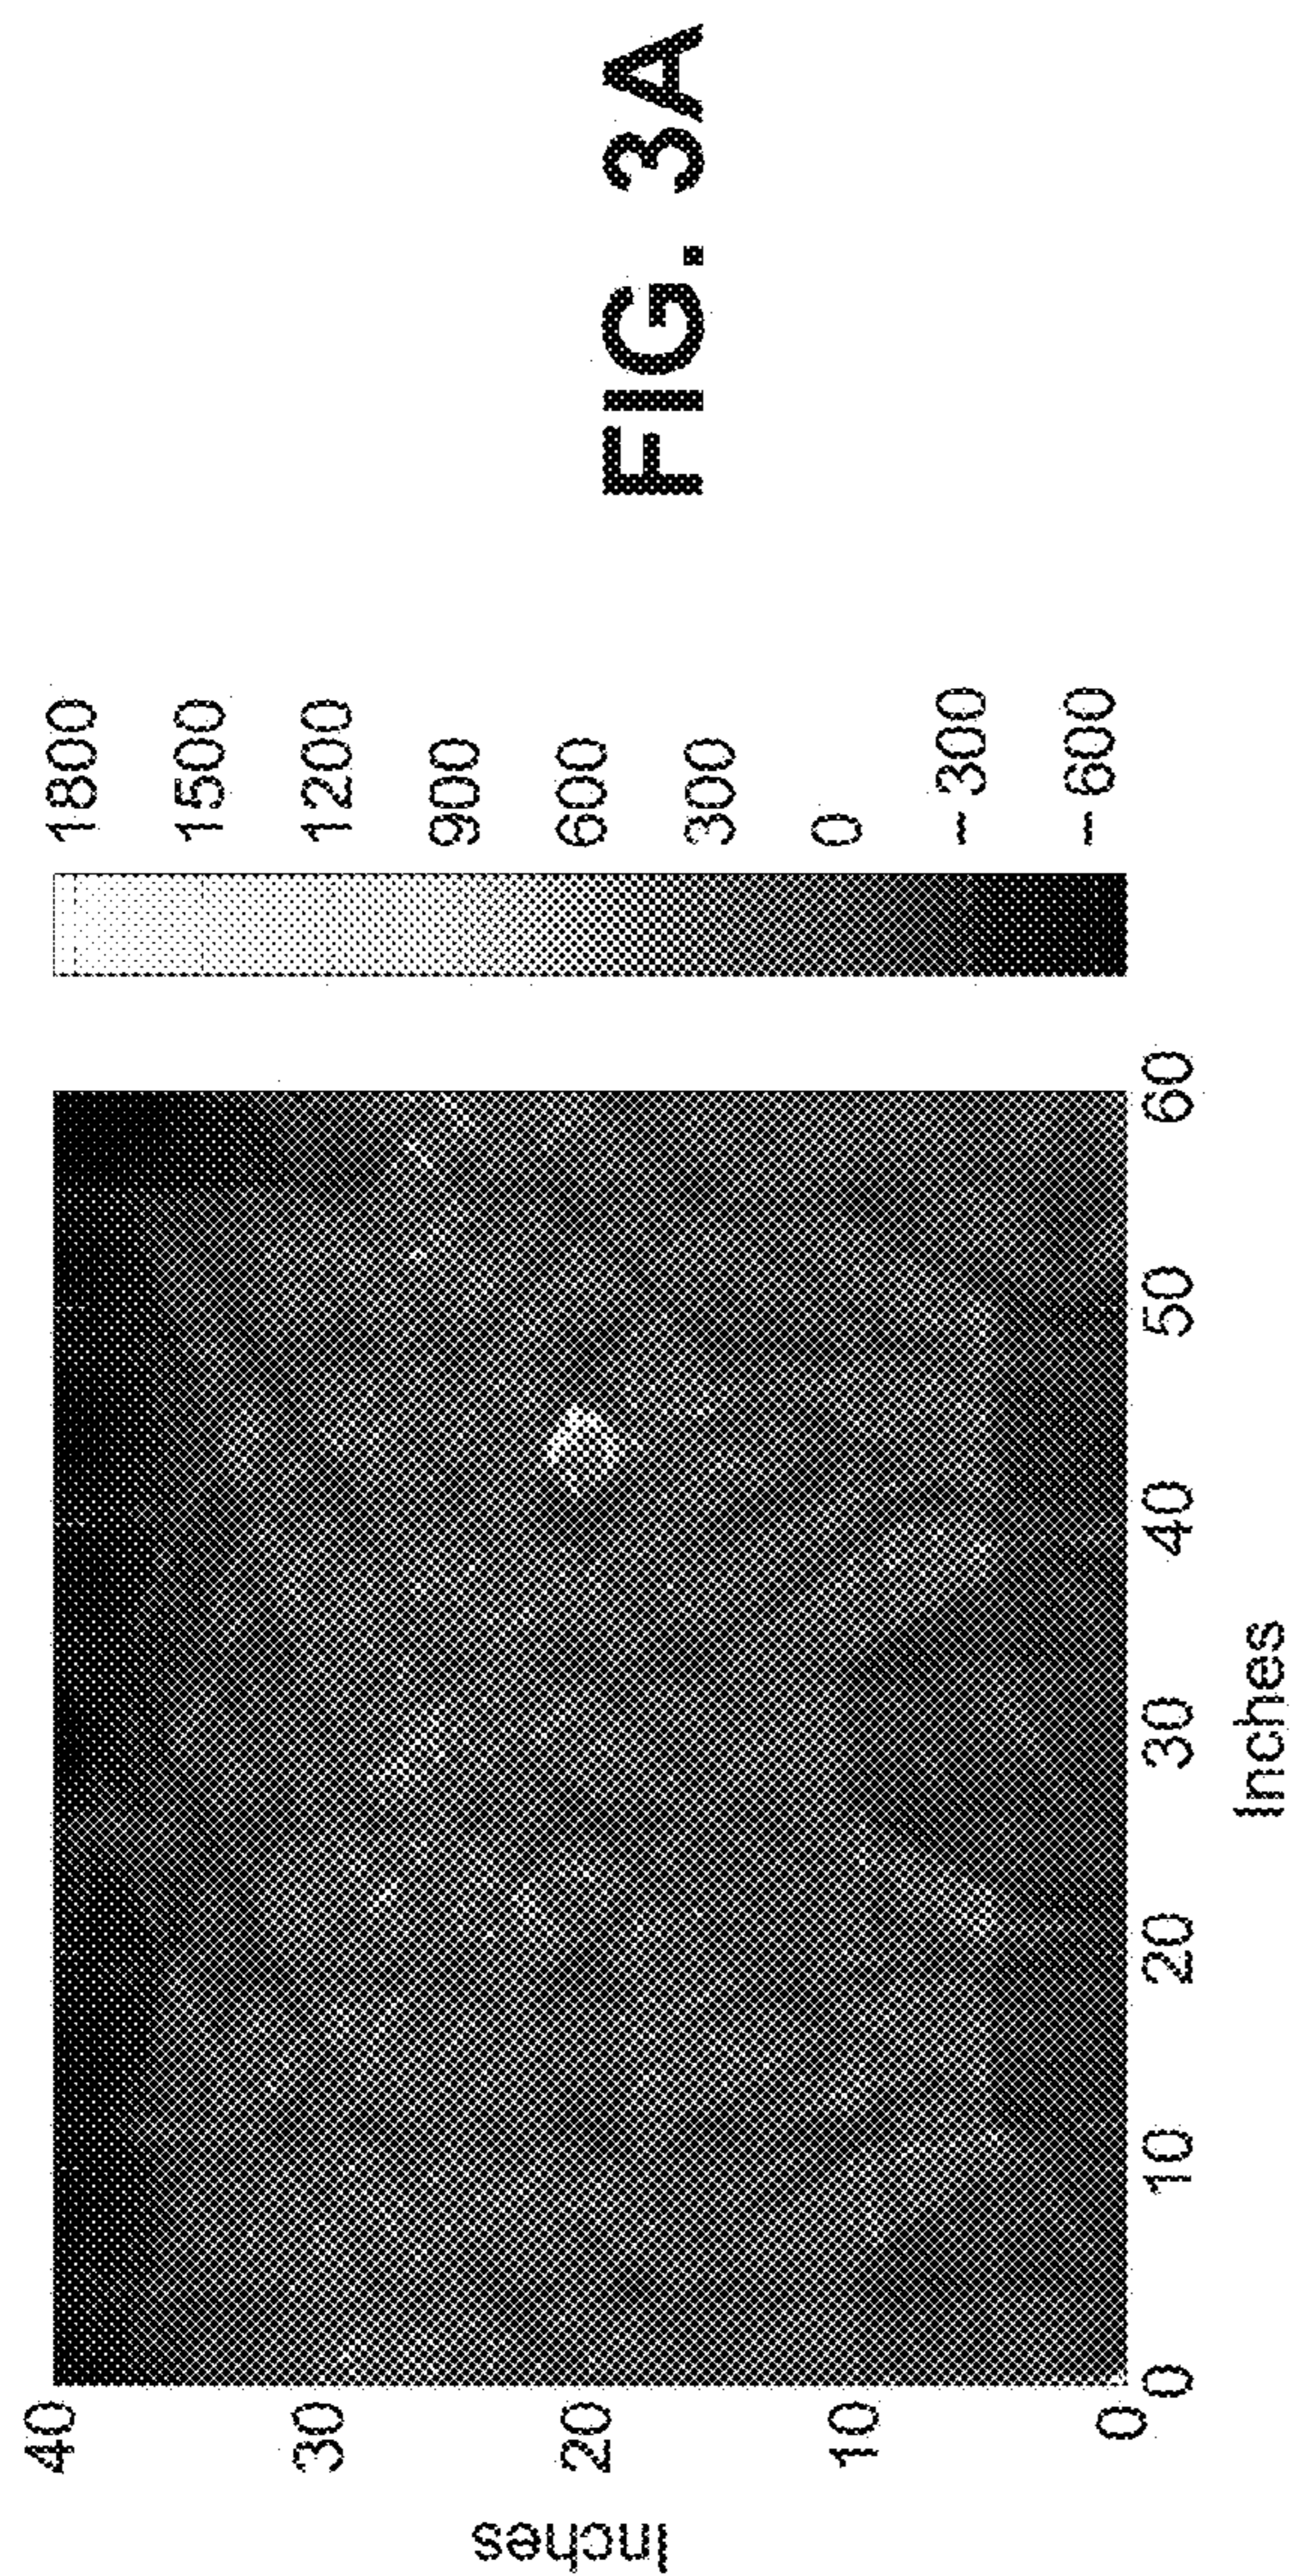
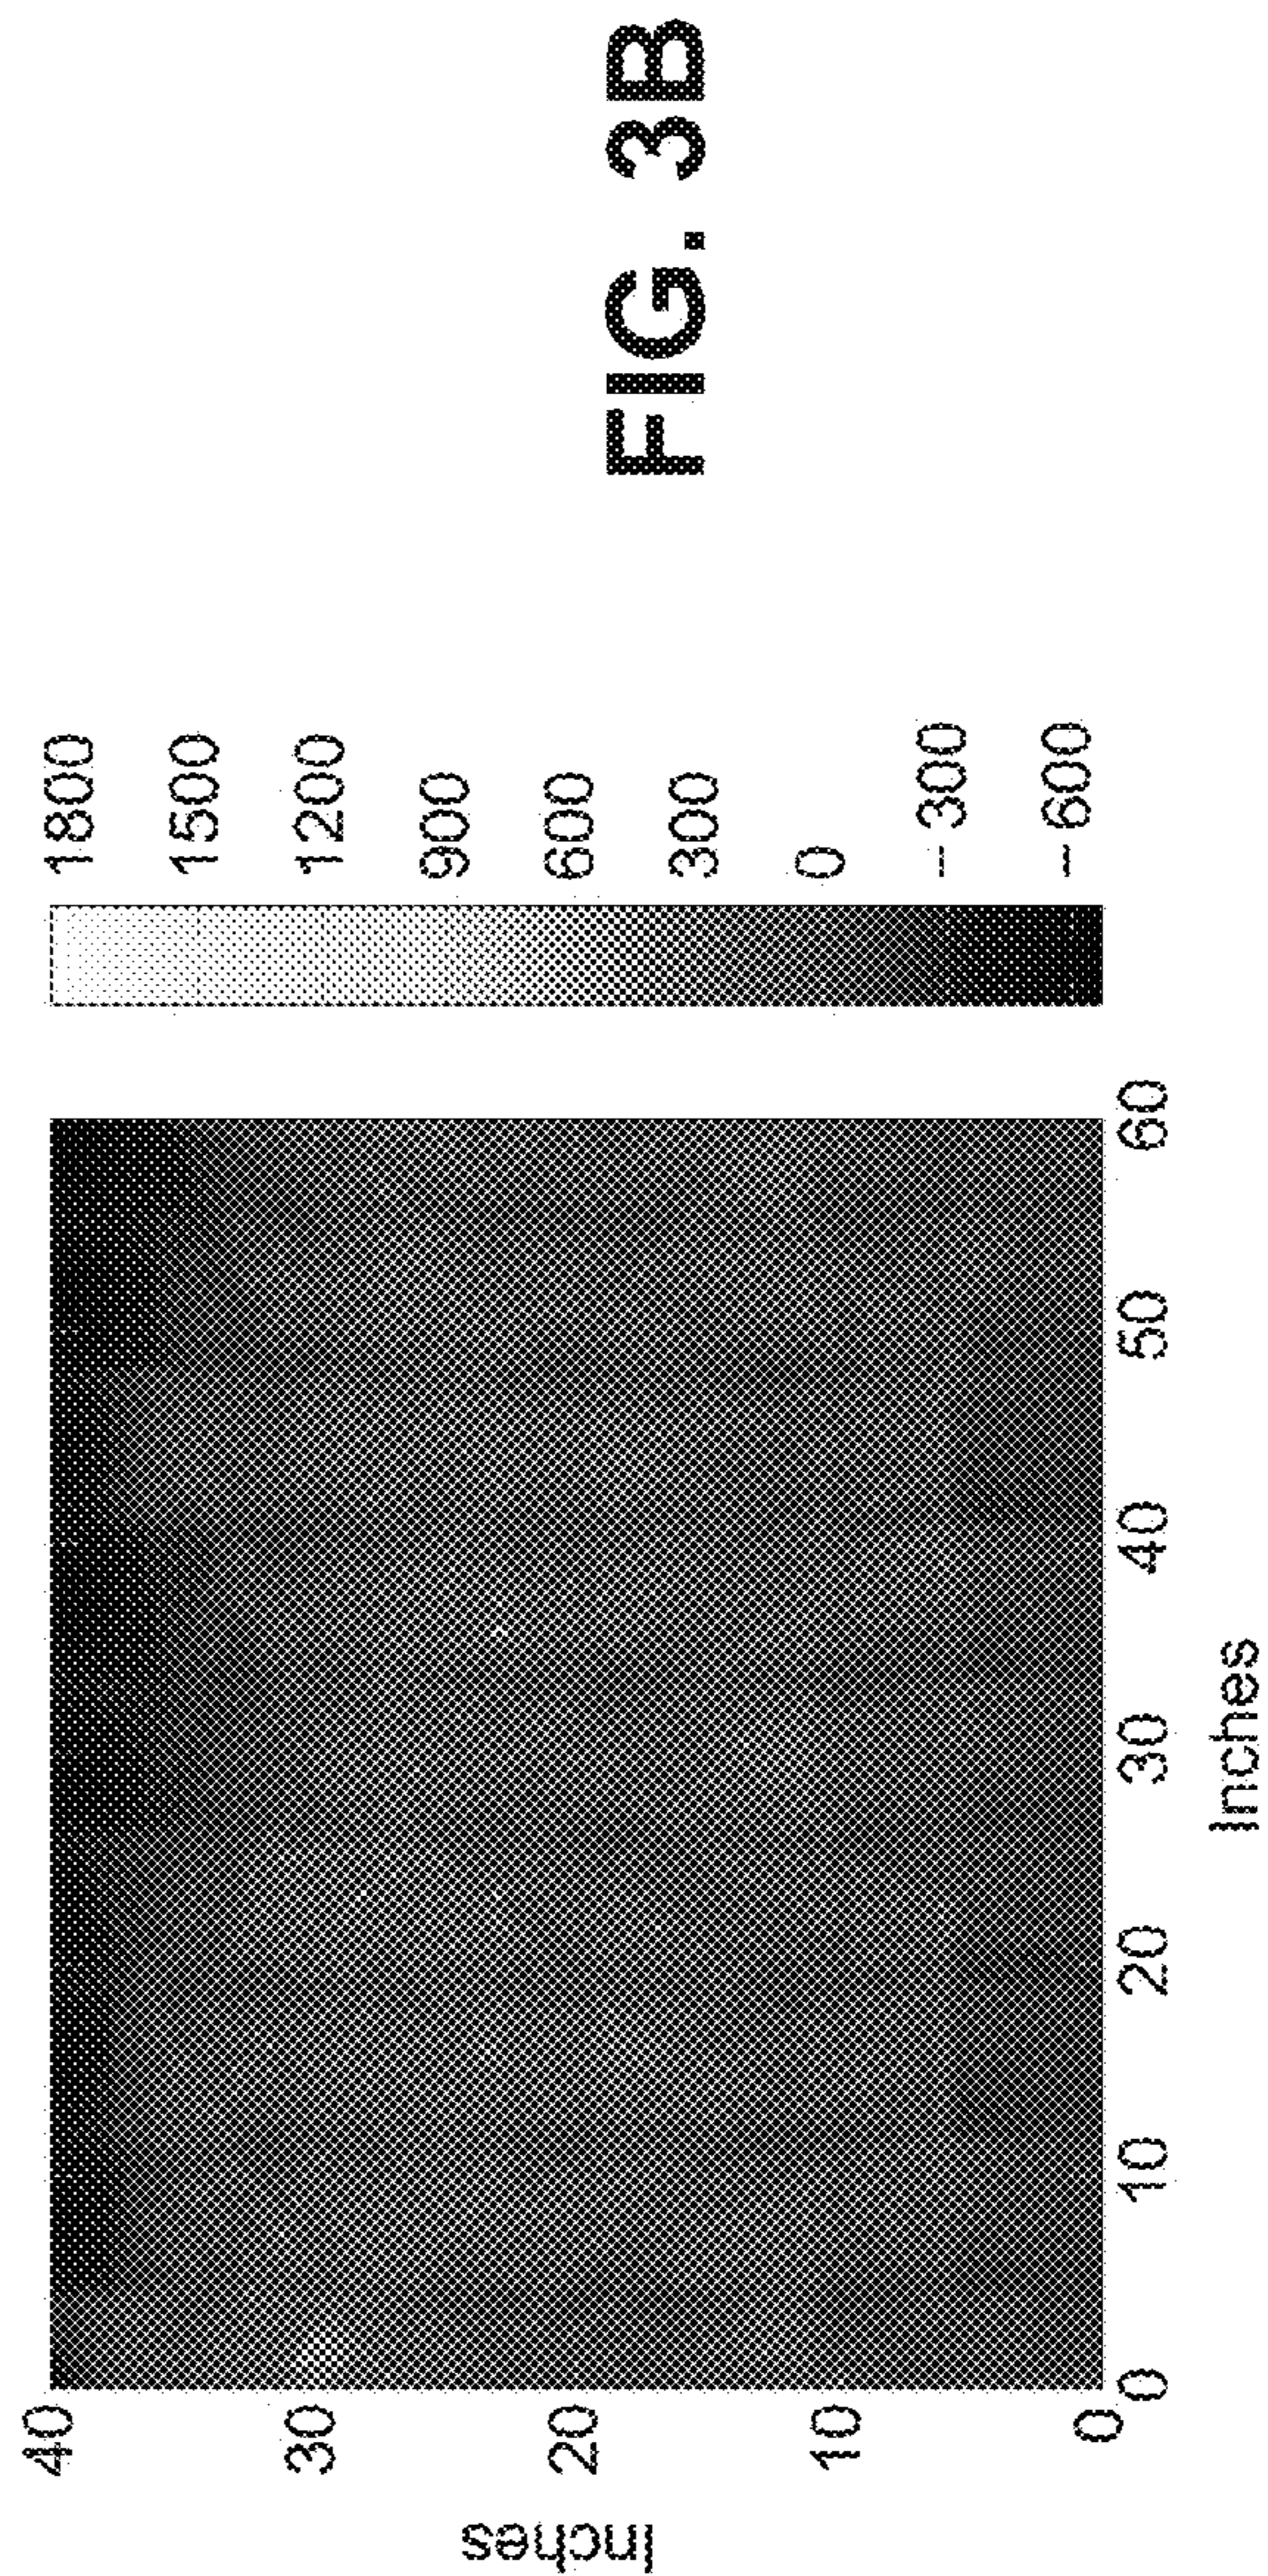
FIG. 3A is an image showing temporally aligned (“composite”) in situ thermography data, showing deviation from an expected value before a debulking cycle;

FIG. 3B is an image showing temporally aligned in situ thermography data, deviation from an expected value after debulking cycle;

FIGS. 3A and 3B are temporally aligned images showing deviation from an expected value for a composite structure. FIG. 3A shows the deviation from the expected value prior to a debulk process, and FIG. 3B shows the deviation from the expected value post-debulk.

Comparing FIGS. 3A and 3B, it is apparent that the number of hot spots is reduced significantly post debulk. Most notably one of the build up patches on the part (the yellow region at about 40, 20 inches) appears to be a very hot in FIG. 3A prior to debulk, implying it has very poor adhesion with the substrate prior to debulking. This spot completely disappears after debulk (FIG. 3B).

The deviation from the expected value appears to be Gaussian in distribution, so a straightforward method of comparing the overall deviation from the expected value was to compare standard deviations. During testing of a part, the distribution of the deviation from the expected value for

all pixels demonstrated that the standard deviation was reduced by debulking for this test part. The expected value in this example is based on averaging so it is a measurement of the “sameness” of pixel values. The process may be utilized for parts having different geometries. For example, during testing the same process was completed for a composite cylinder structure. The scans of the cylinder were completed by running the program for a full coverage ply that was one continuous helical path, without laying fiber. In addition to analyzing the laminate quality prior to cure, the collected data enables engineers and designers to make predictions regarding post-cure part quality.
