(54) **METHOD AND MEANS TO ANALYZE THERMOGRAPHIC DATA ACQUIRED DURING AUTOMATED FIBER PLACEMENT**

(71) Applicant: **United States of America as represented by the Administrator of NASA, Washington, DC (US)**

(57) **ABSTRACT**

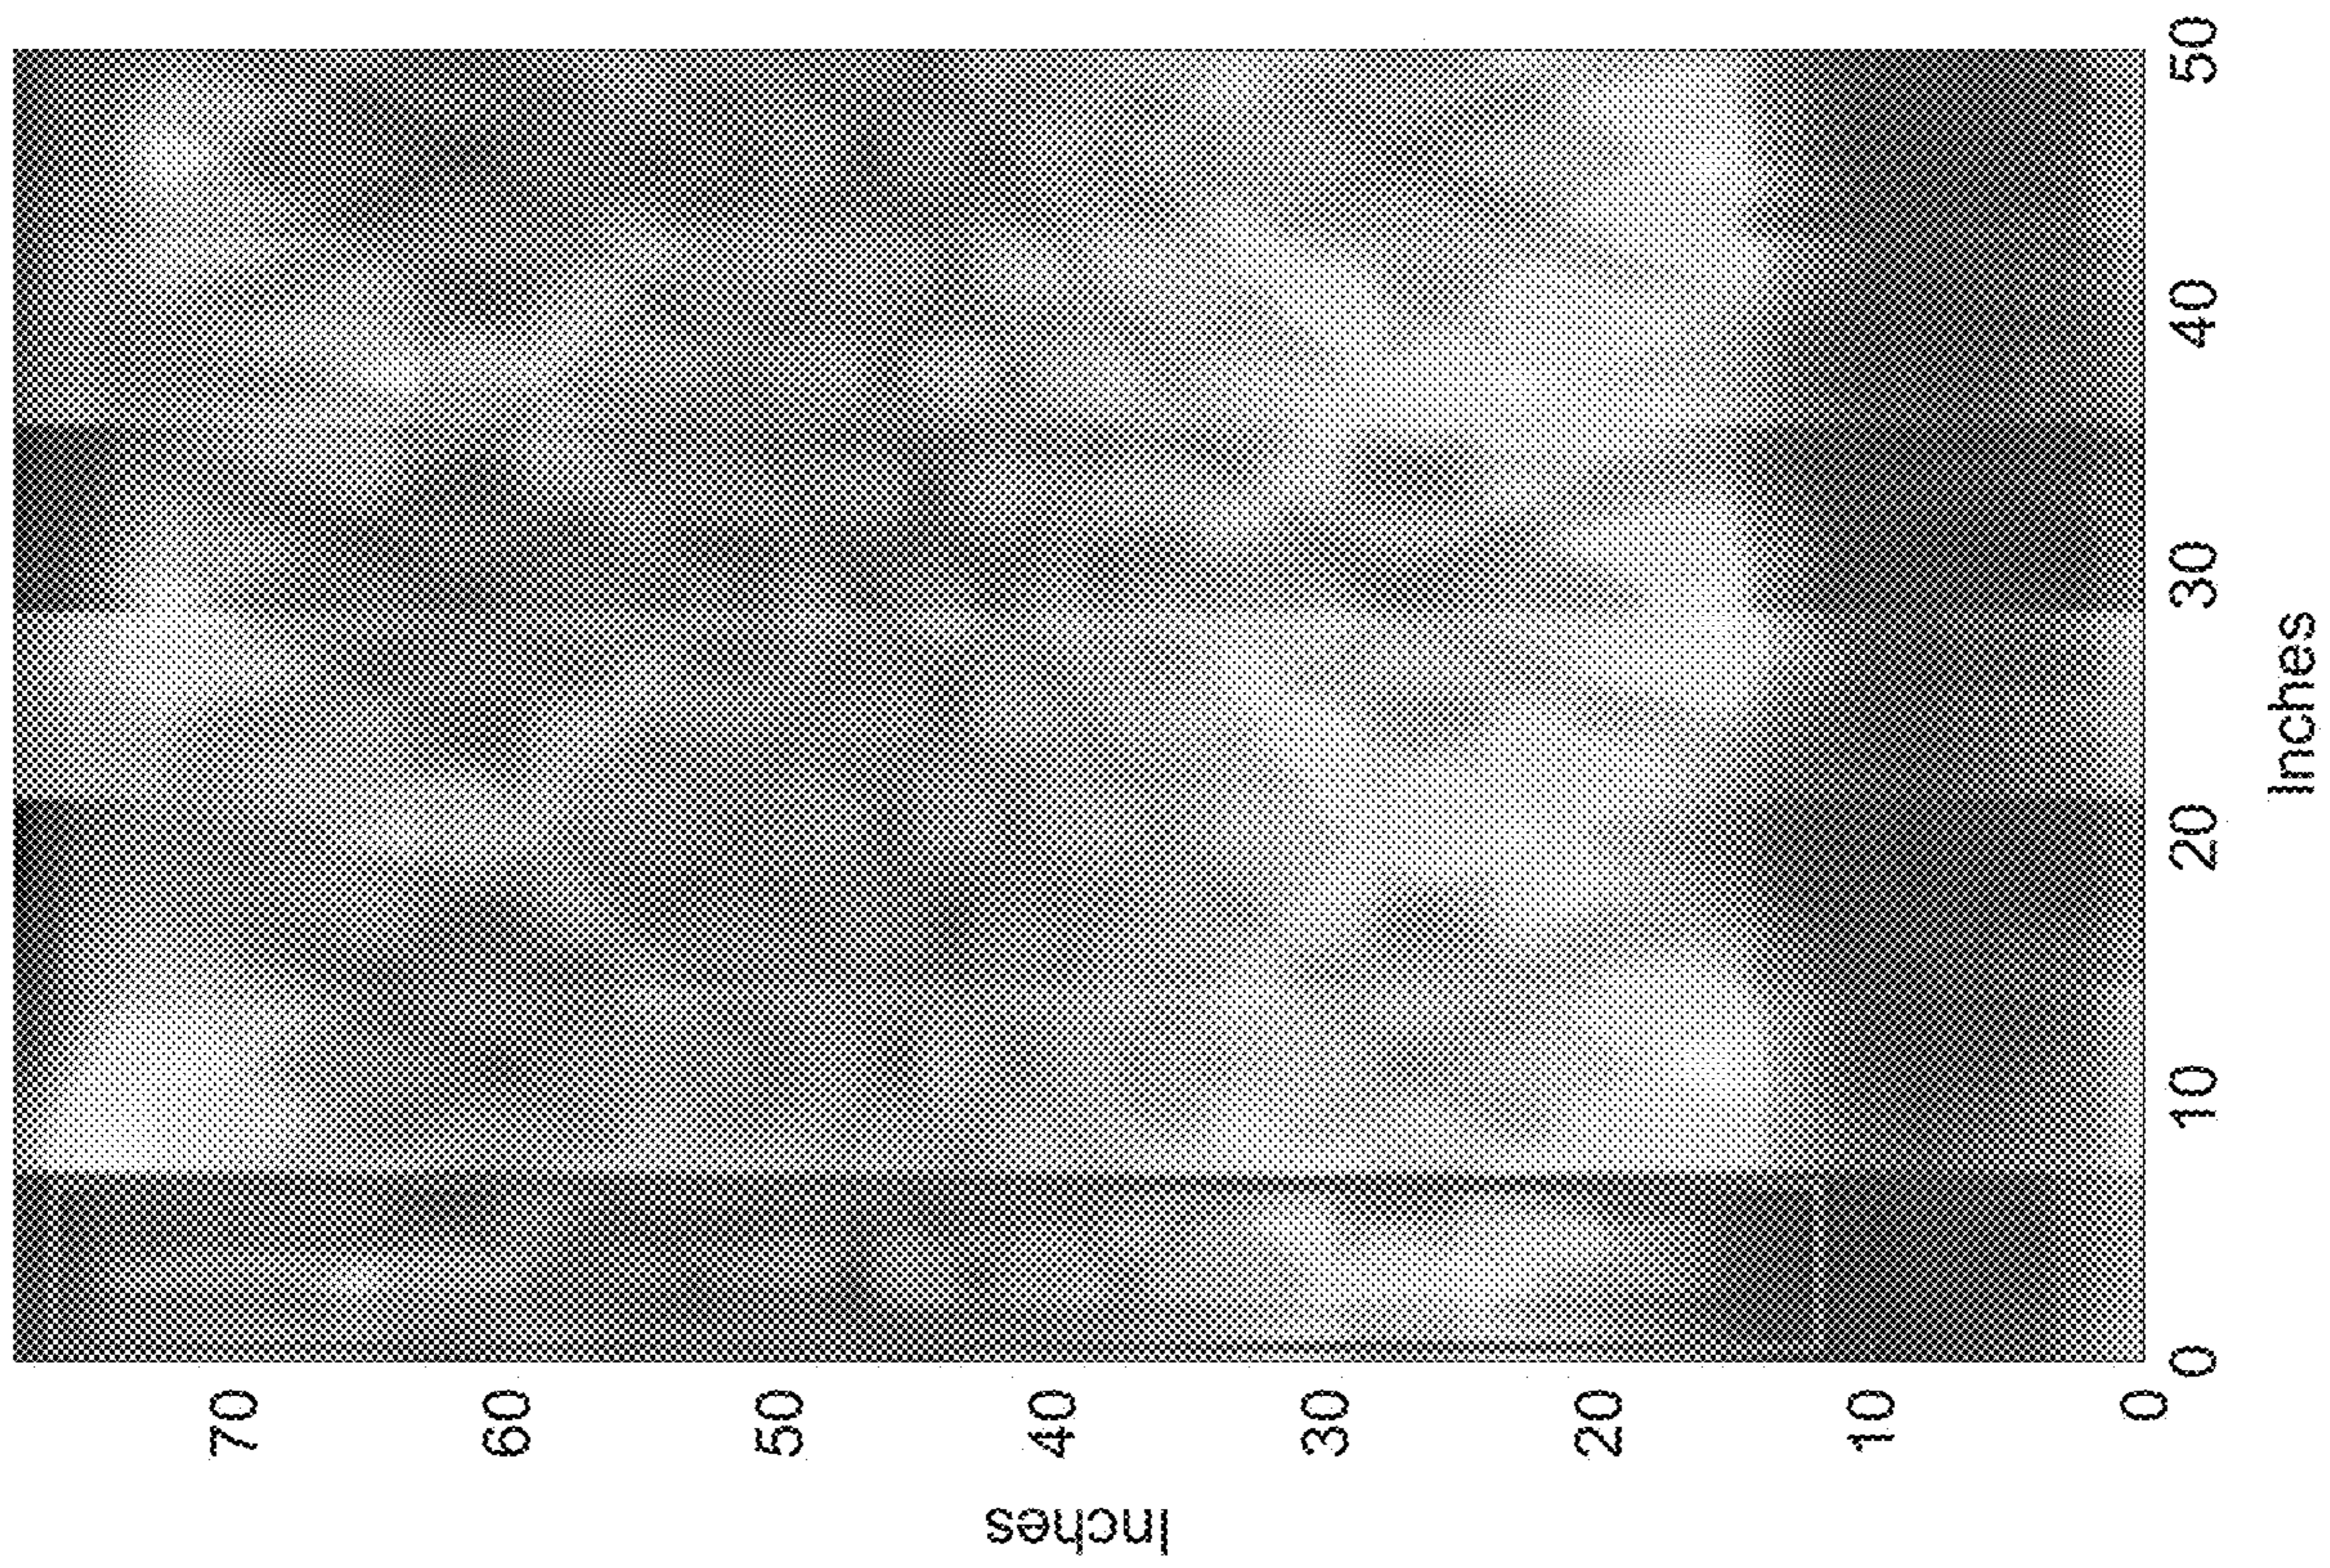
FIG. 3C is a post cure thermal line scan of a part, wherein the data is temporally aligned and spatially registered;

In order to establish a relationship with post-cure part quality thermal line scan data of a composite structure may be collected after cure. This process does not necessarily require use of an AFP system. For example, in one test this scan was completed in a laboratory where the composite structure (a cylinder) was placed in a rig that rotated the cylinder at a constant speed. A thermal camera was placed at various positions along the length of the cylinder, and the thermal camera collected data for a complete rotation. The part was heated by a line source located below the thermal camera. FIG. 3C shows the temporally aligned and spatially registered data for part of the length of the cylinder (the cylinder is not the same part used to generate FIGS. 3A and 3B). This data (FIG. 3C) is not deviation from the expected value; it is raw counts. Brighter areas may be areas where the laminate is thinner or areas where heat is not being conducted through the thickness as efficiently as darker areas. Likewise, areas that are darker may be thicker. The bright yellow “X-like” areas in the lower half of FIG. 3C (and less obviously, in the upper half) correspond to the areas between tow-steered plies that are thinner. There also appears to be some overlap of tow-steered plies or thickening of those plies at the edges of a course. This may be the result of tow peel-up. One feature that was not observed in the pre-cure data was the strip of varying width (outlined by a blue box) on the left side of FIG. 3C. This strip of lighter areas may be from a helical ply.

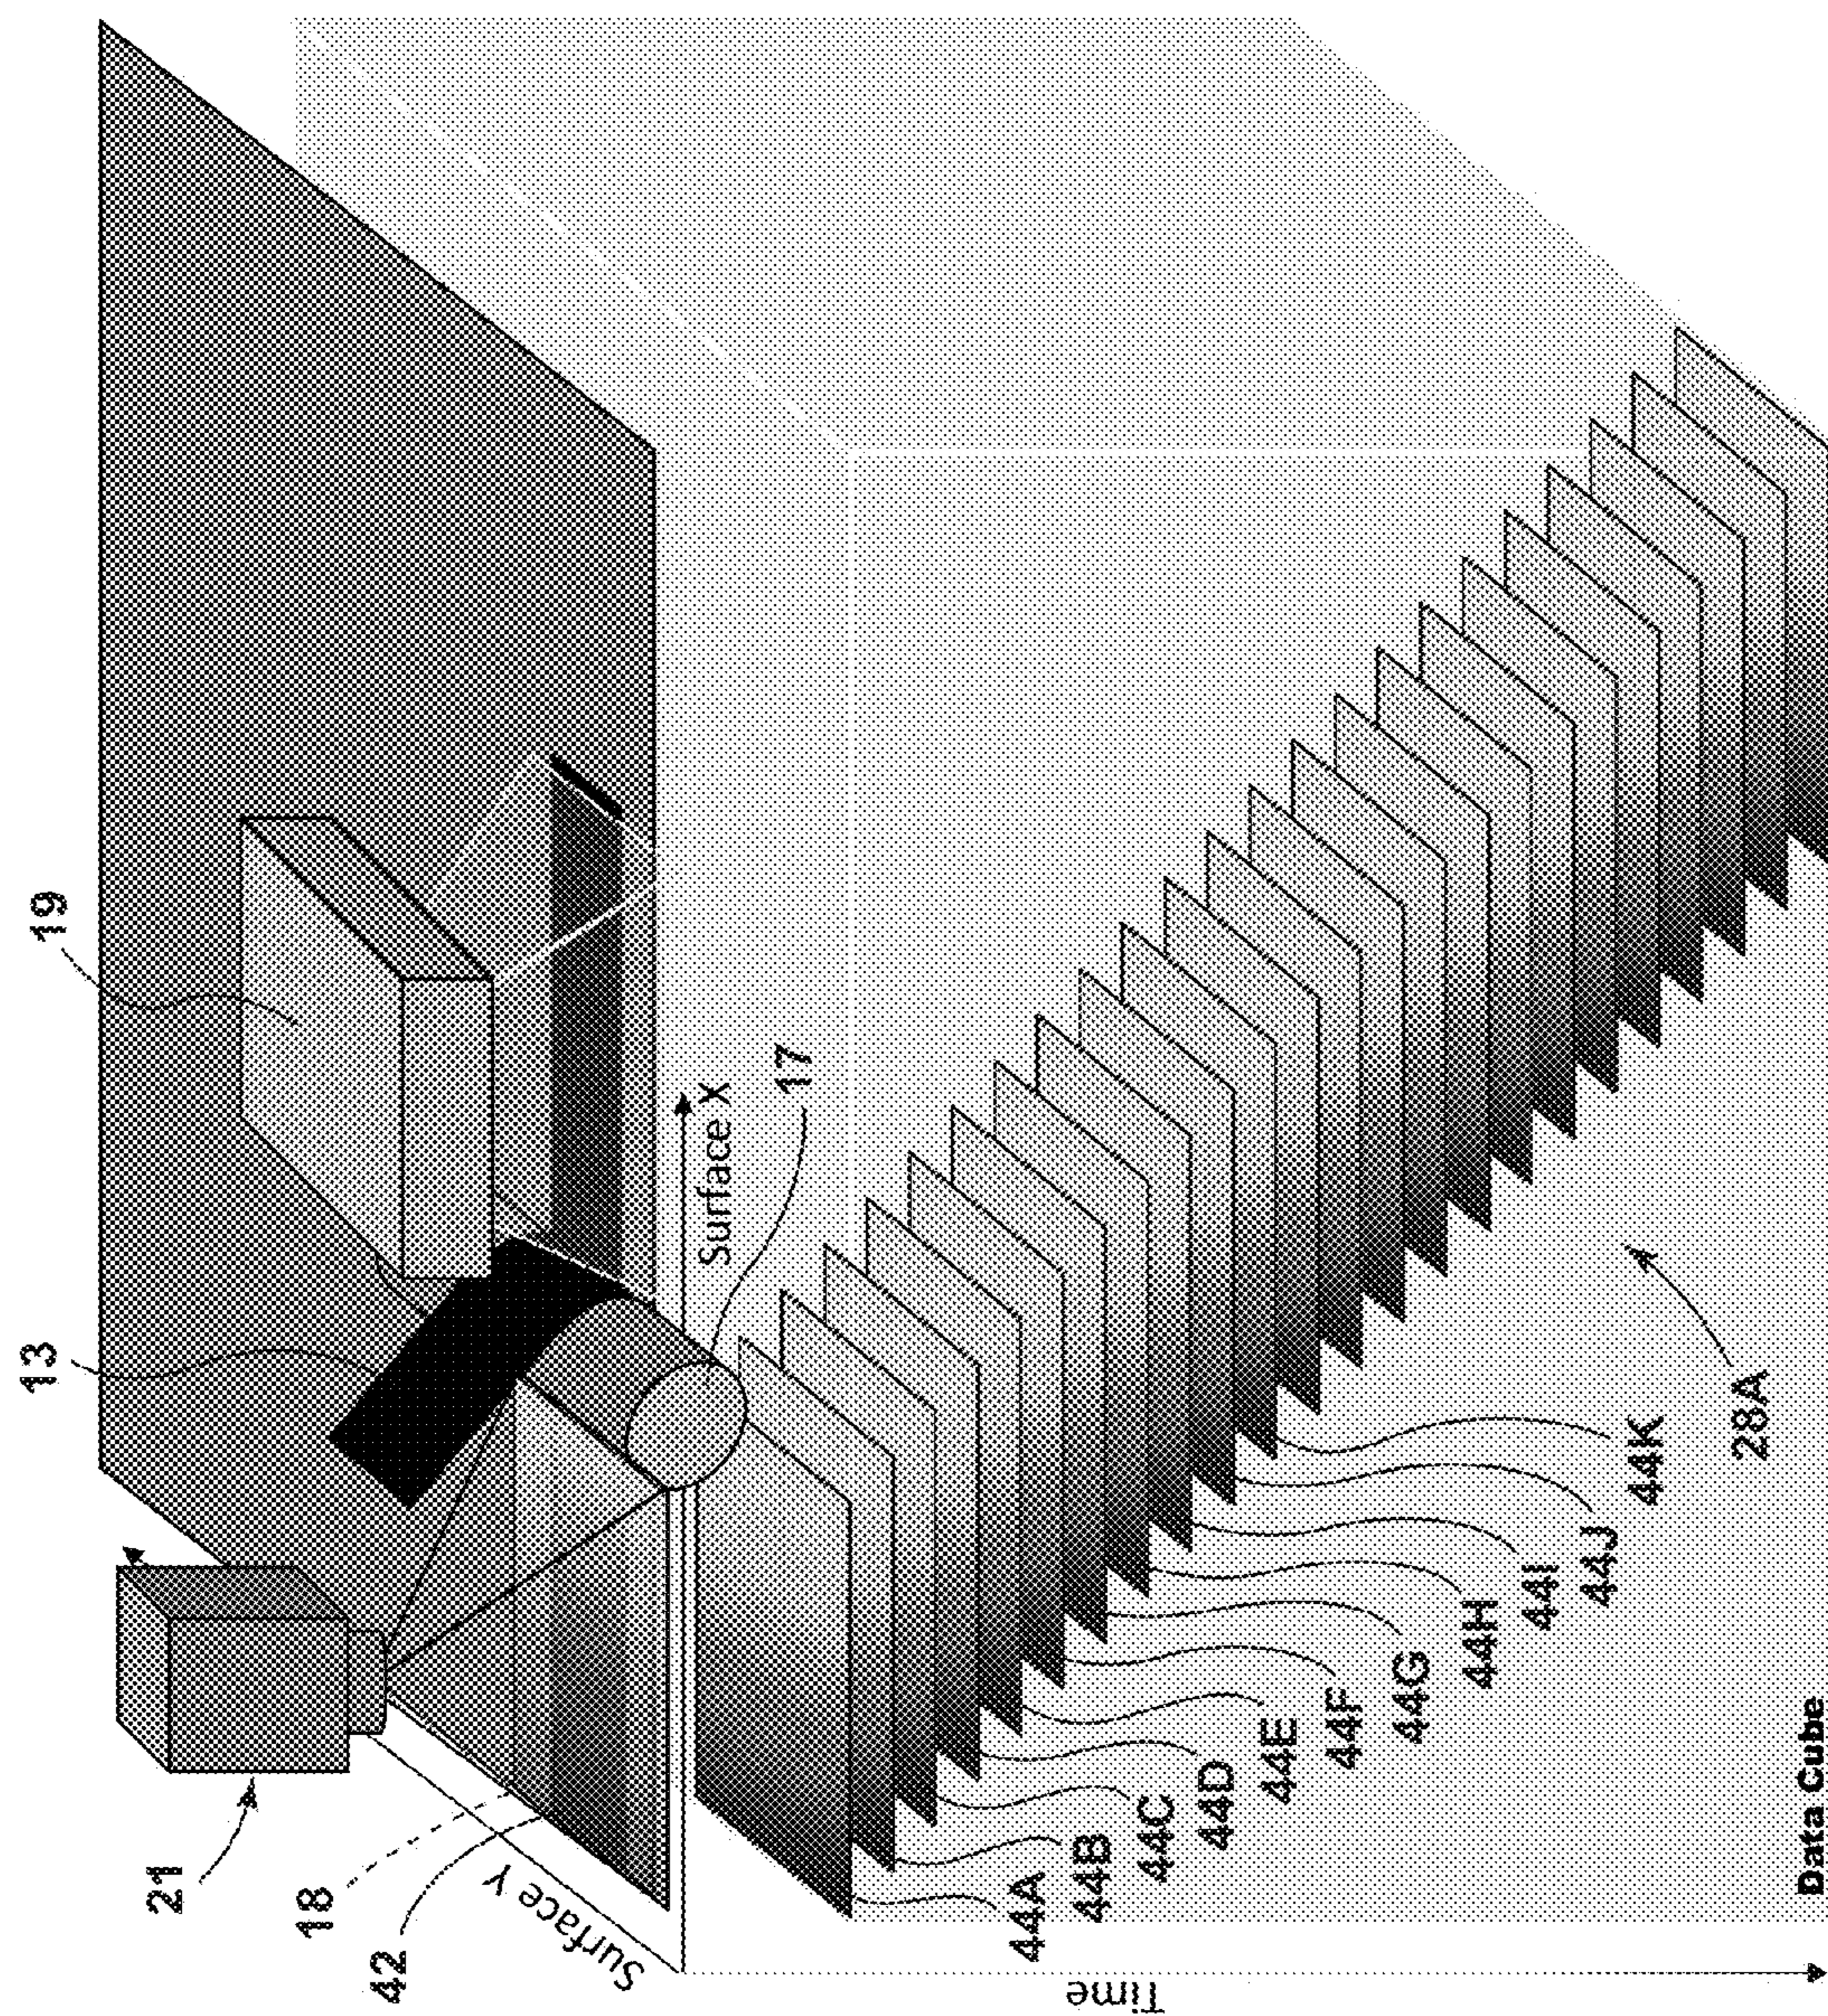
FIG. 4A is an isometric schematic view of an AFP system, infrared camera, and image data;

With reference to FIG. 4, head 15 deposits the tow strips 30 along a material course or path 42. The head 15 generally travels in a direction indicated by the arrow “B.” It will be understood material course 42 may be non-linear, and the orientation of arrow “B” may change as head 15 moves along course 42. With reference to FIG. 4A, as the head 15 moves along the course 42, camera 21 captures a series of thermal images (“frames”) 44A, 44B, 44C, etc. that form a series 28A of original or initial thermal images or frames.

Images or frames 44A, 44B, 44C, etc. comprise original image data captured by camera 21. Because camera 21 and the heat source (e.g. lamp 19) are moving relative to the part when the frames 44A, 44B, 44C are captured, the portions of the image that are closer to the roller 17 and heat source 19 have been heated more recently than the regions of frames 44A, 44B, 44C, etc. that are further away from roller 19 and heat source 19.

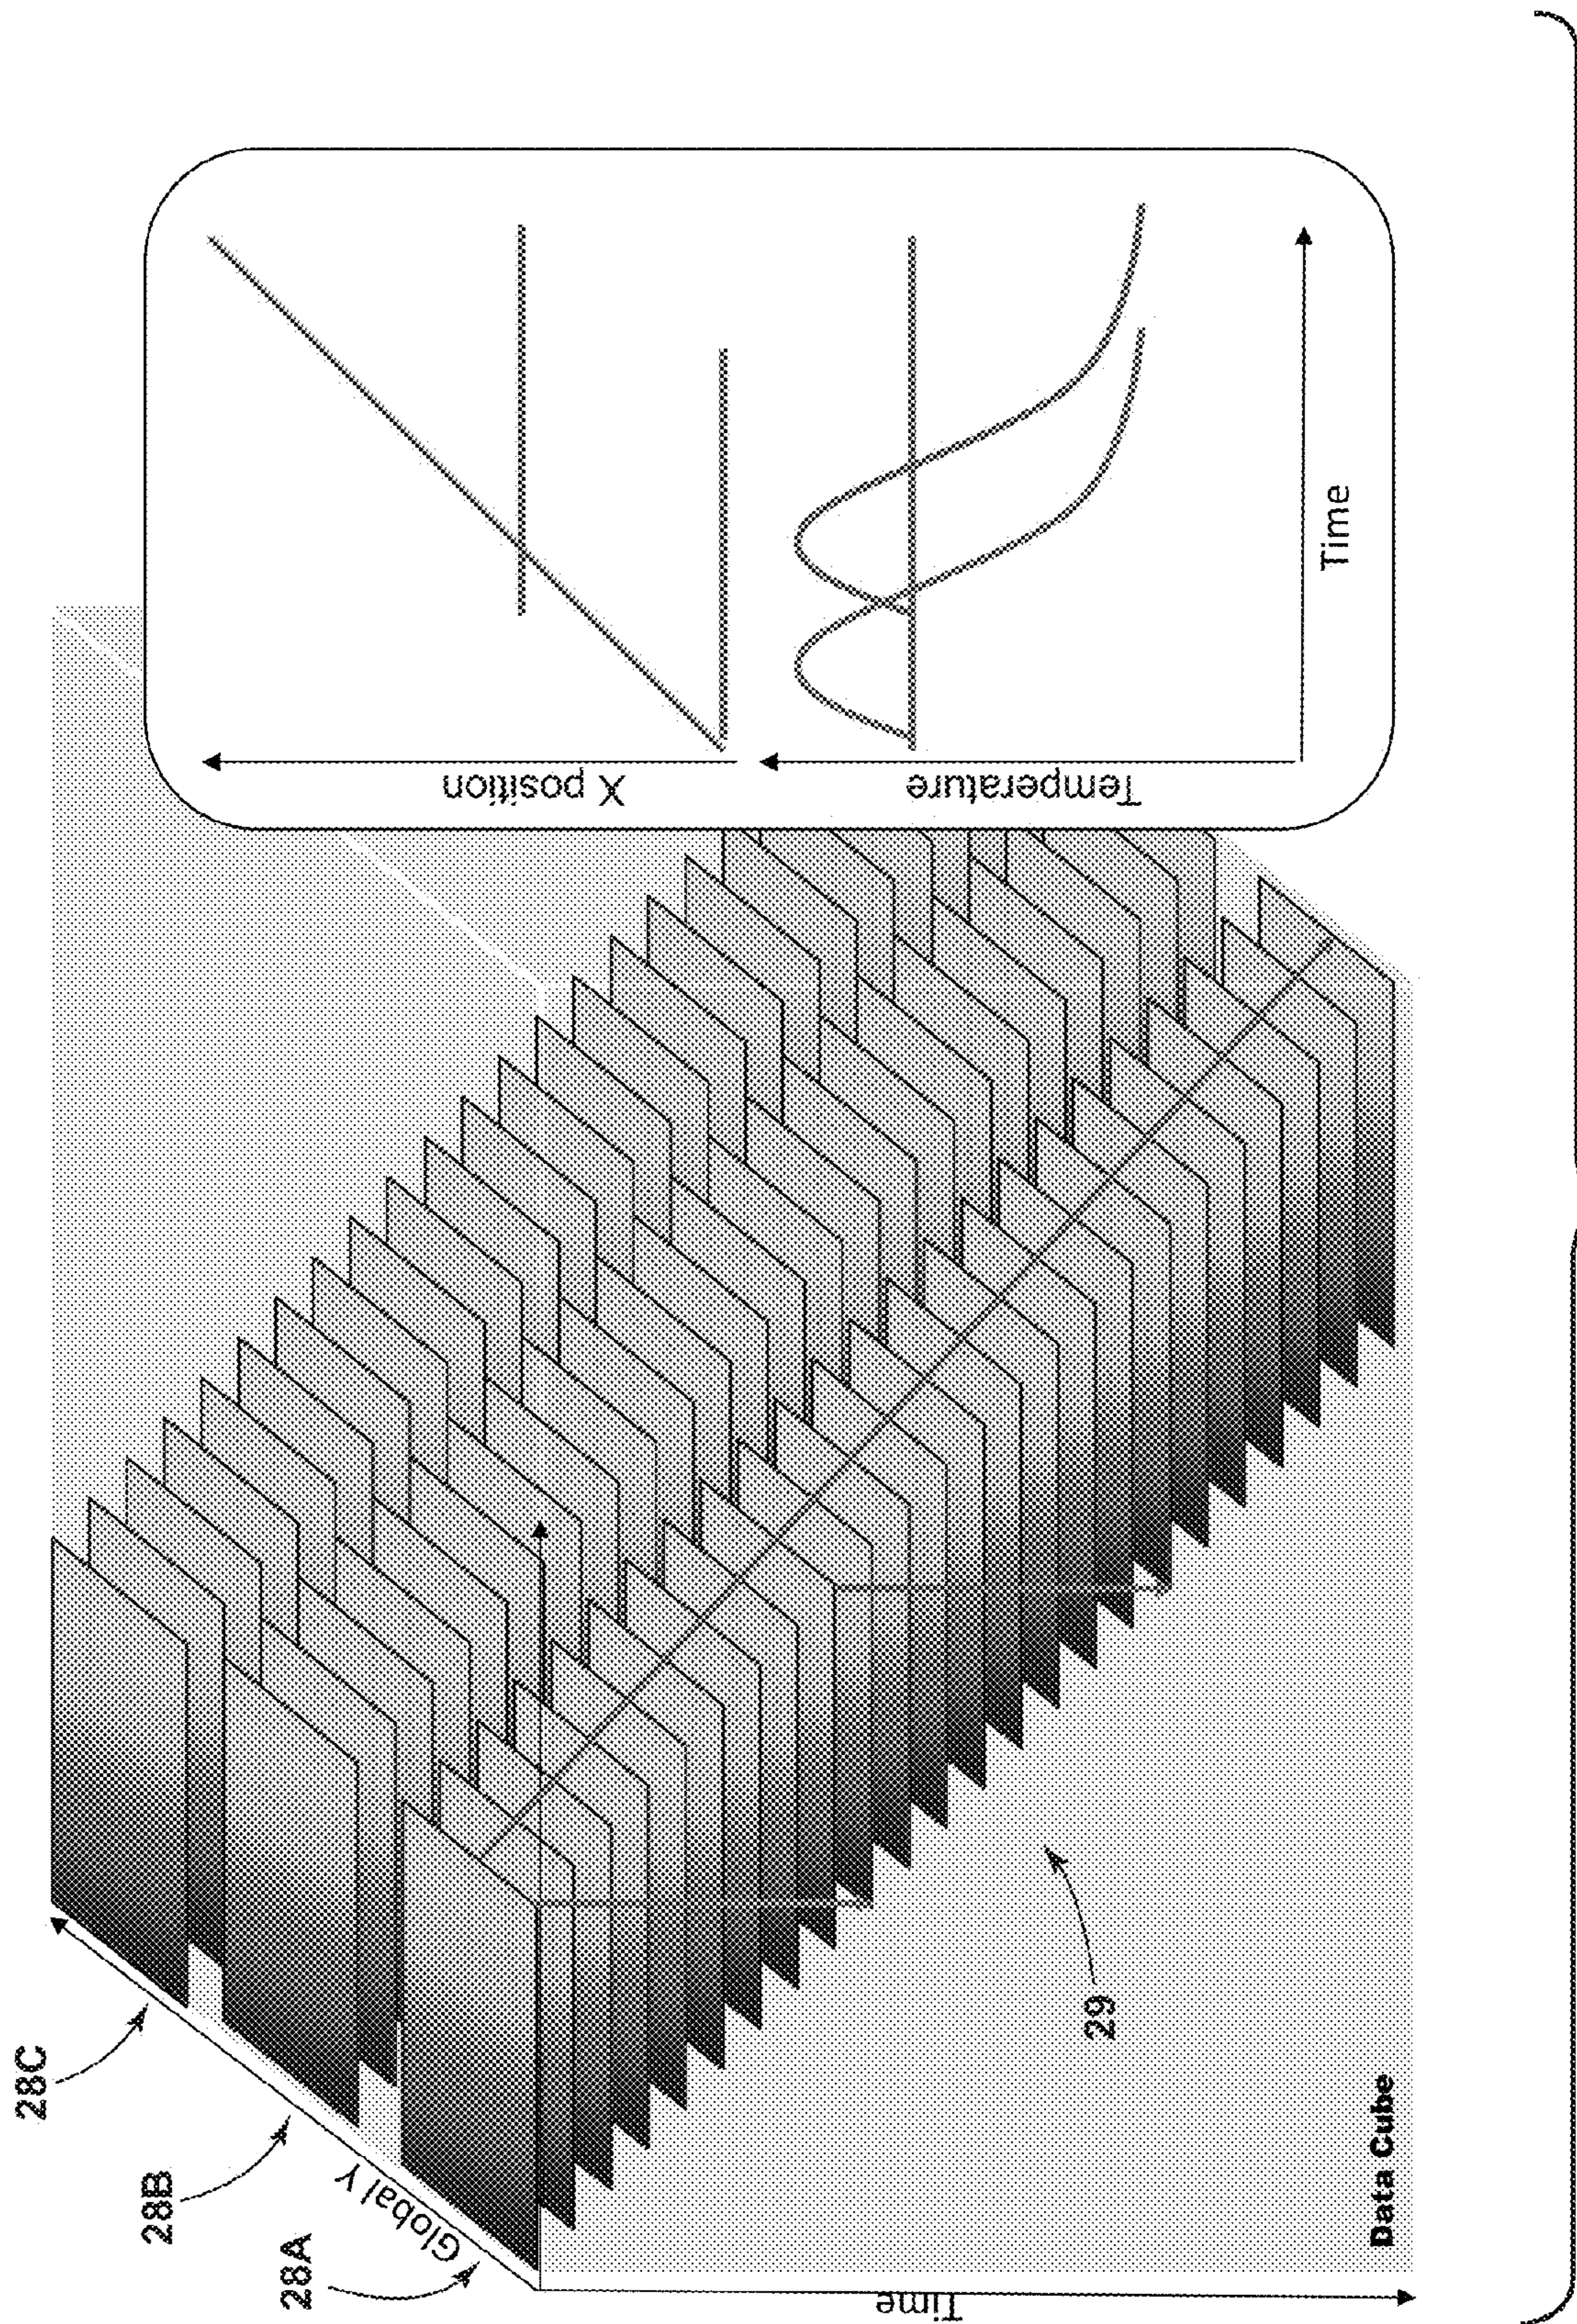
FIG. 4B is a schematic showing image data generated by the infrared camera of FIG. 4A;

With reference to FIG. 4B, as the camera 21 makes additional passes that are spaced apart along the “Y” axis, additional series of images or frames 28B, 28C, etc. are generated to form a data cube 29. Individual points or regions taken from each original frame/image 44A, 44B, 44C etc. can be assembled to form a temporally synchronized cell or image 44 (FIG. 4). As discussed in more detail below in connection with FIG. 4C, the individual points or areas 46A, 46B, 46C, etc. comprise different areas of the part surface wherein the individual points or small areas 46A, 46B, 46C, etc. show the surface areas at an equal time after

the area 46A, 46B, 46C etc. is heated. For example, the image 44 may show a region of the part surface in which the areas 46A, 46B, 46C etc. are all taken from images one second after each individual area 46A, 46B, 46C etc. has been heated. Thus, although the actual surface of the part is heated at different times, the temporally synchronized cell or image 44 is created by taking small points or areas (pixels) from the original images 44A, 44B, 44C, etc. that are reassembled such that the individual areas 46A, 46B, 46C are all shown at the same amount of time after being heated. For example, temporally synchronized image 44 may comprise smaller areas 46A-46I in the form bands that are taken from individual images 441-44A, respectively (FIG. 4A). The temporally synchronized thermal image 44 is formed using image data for each point that is captured/collected at a time 48 that is after the tow strips 30 have been applied to the substrate. As shown by the line 47, the surface temperature of the tow varies over time. In general, the temperature rises initially as shown by the line segment 47A, reaches a peak at line segment 47B, and then declines as shown by the line segment 47C.

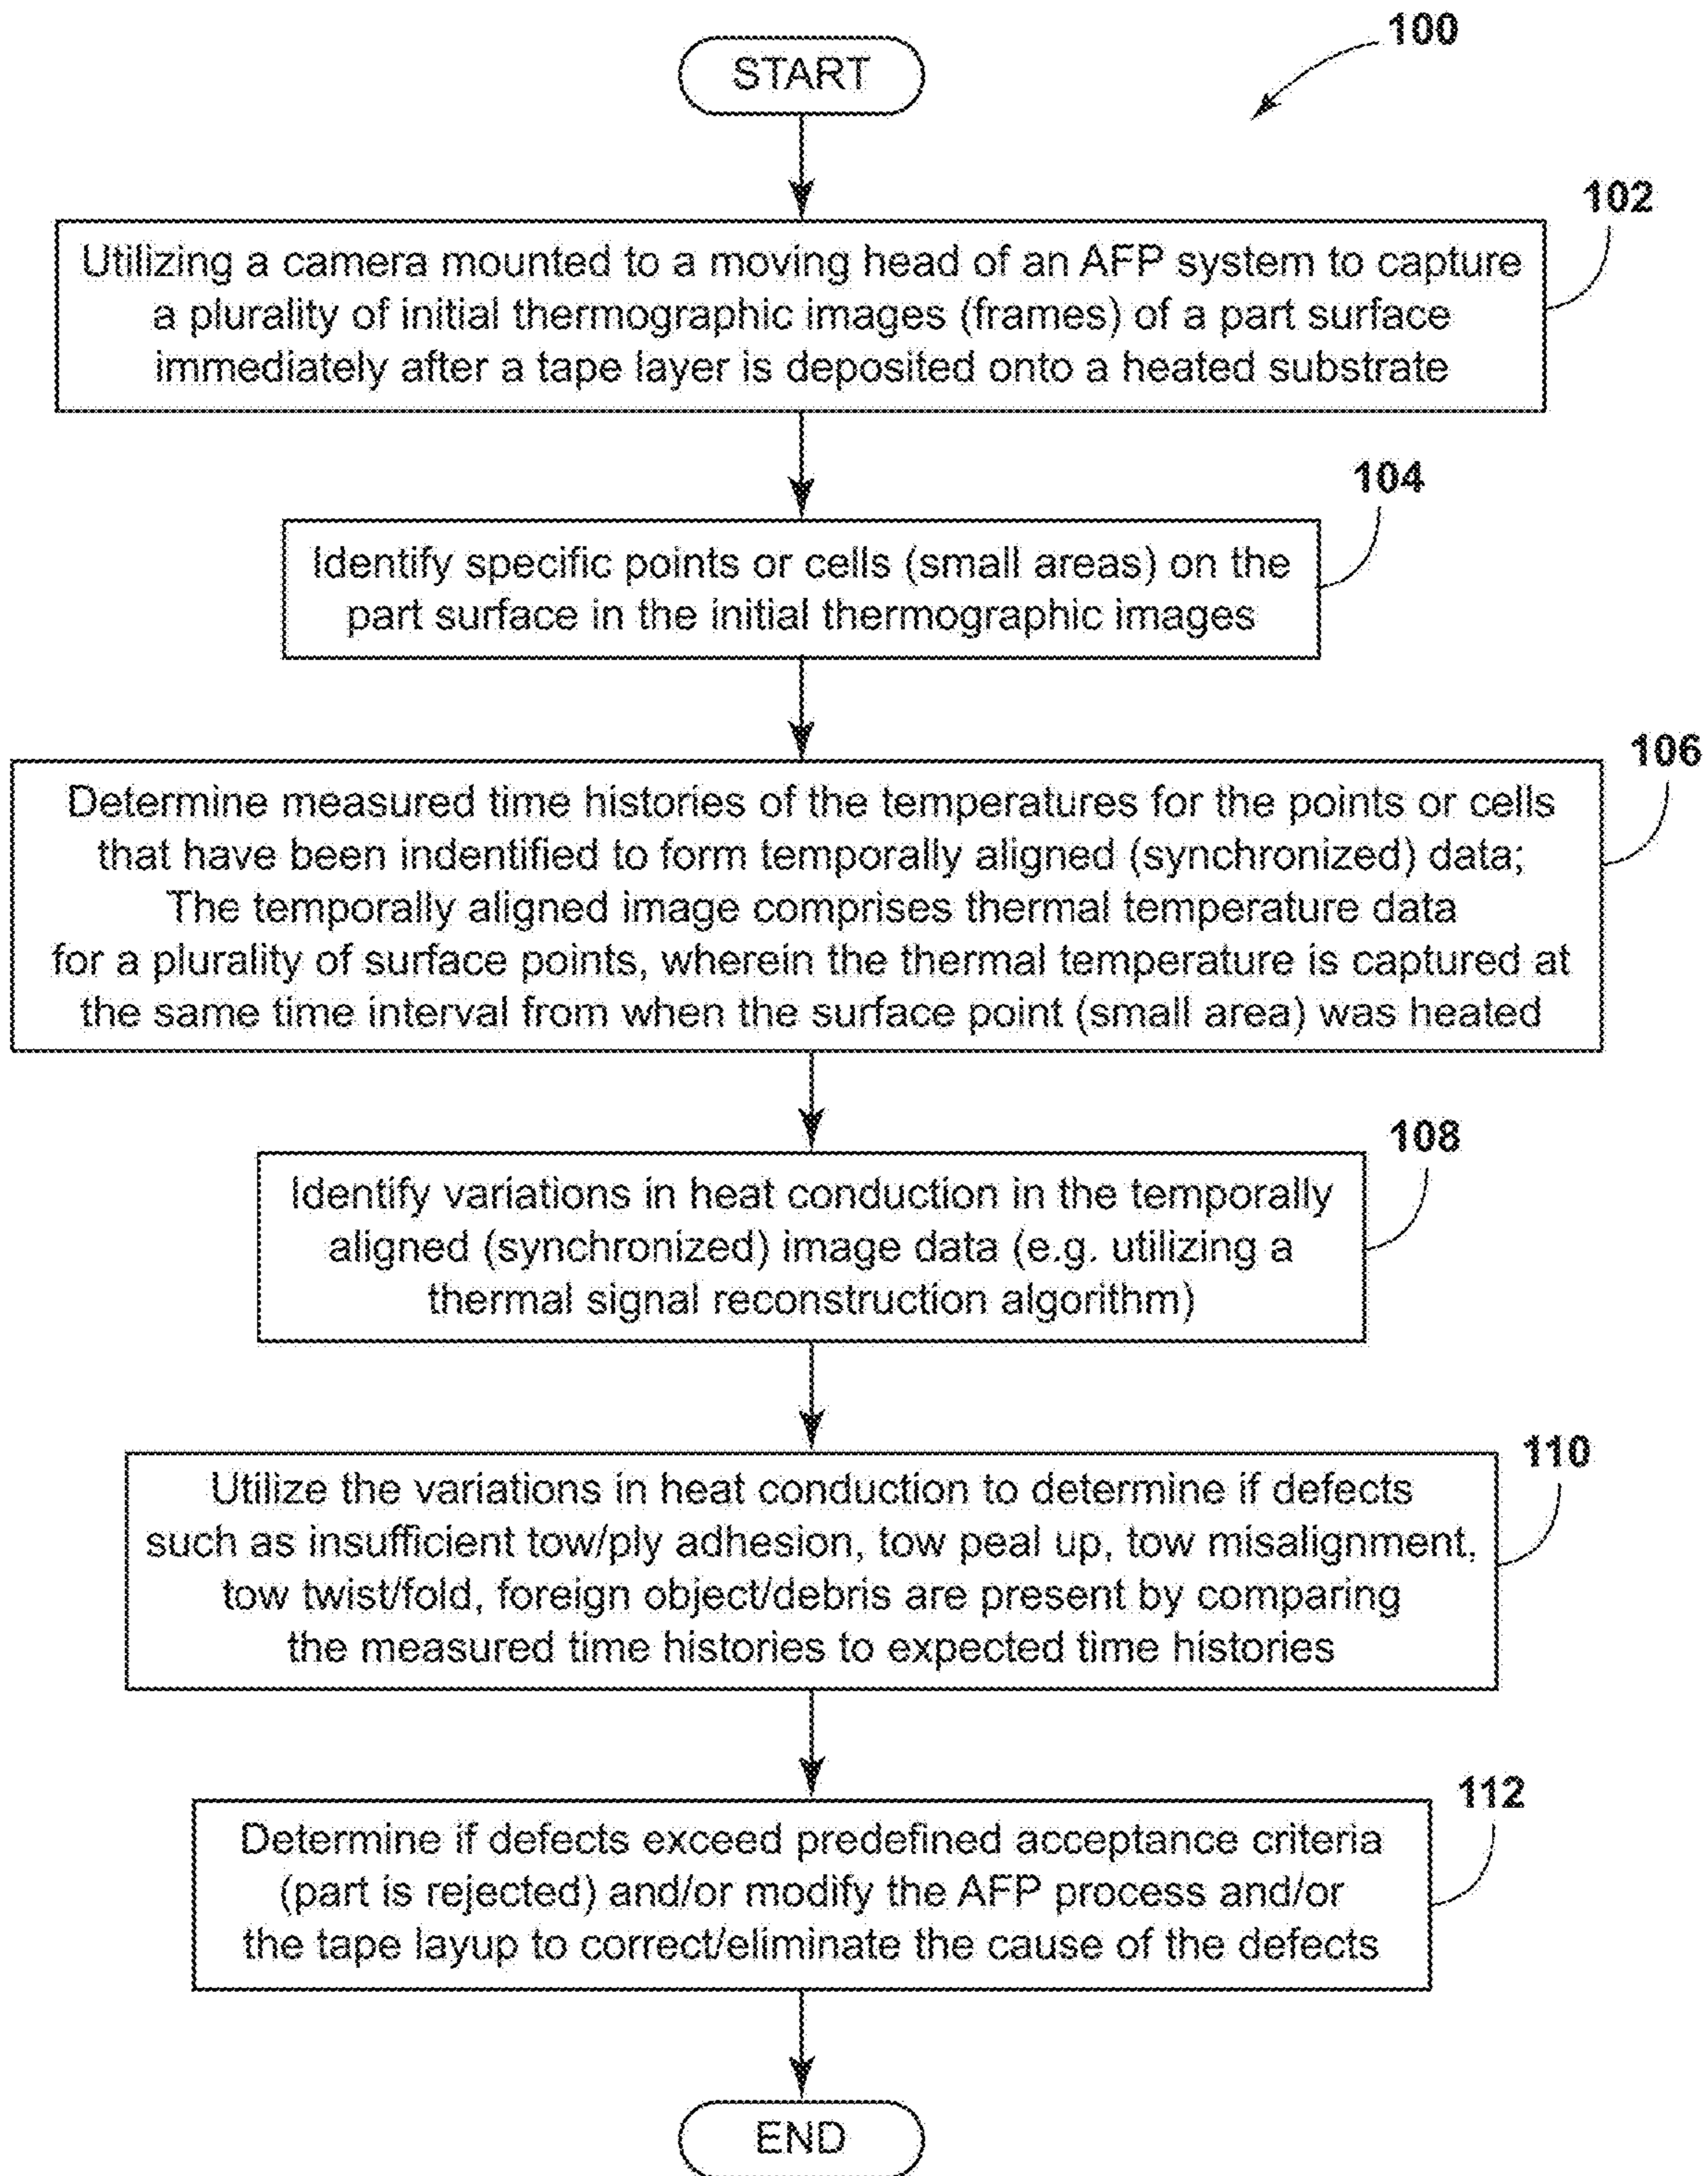
FIG. 4C is a flowchart showing thermographic data processing according to one aspect of the present invention;

With further reference to FIG. 4C, a process 100 according to one aspect of the present invention generally includes a first step 102 in which a camera mounted to a moving head of an AFP system is utilized to capture a plurality of initial thermographic images (frames) of a part surface immediately after a tape layer is deposited onto a heated substrate. Step 102 may, alternatively comprise a line scan process that includes heating a surface of a part without depositing a tape layer. The initial thermographic images include areas that were heated at different times.

At step 104, specific points or cells (small areas or pixels), on the part surface are identified in the initial thermographic images. At step 106, measured time histories of the temperatures for the points are determined, and a temporally aligned (synchronized) image is formed. The temporally aligned image comprises thermal temperature data for a plurality of surface points, wherein the thermal temperature data is captured at the same time interval from when the surface point was heated.

At step 108, variations in the temporally aligned image data (caused by variations in heat conduction) are identified. A thermal signal reconstruction algorithm or other suitable approaches may be utilized to identify and/or evaluate variations. The variations may comprise variations from expected data, or the variations may comprise "absolute" variations in the data.

At step 110, variations in the data (e.g. due to variations in heat conduction) are utilized to determine if defects are present. The temporally aligned data may be evaluated utilizing algorithms (software) previously utilized to analyze thermal image data generated by flash thermography or other such processes. The defects may comprise insufficient tow/ply adhesion, tow peel up, tow misalignment, tow twist/fold, foreign objects/debris, etc. Defects may be detected by comparing the measured time histories to expected time histories. At step 112, if defects exceed predefined acceptance criteria a part may be rejected and/or the layup or process may be modified. The AFP process, tape layup etc. may be modified to correct or eliminate the cause of the defects even if defects do not exceed predefined criteria.

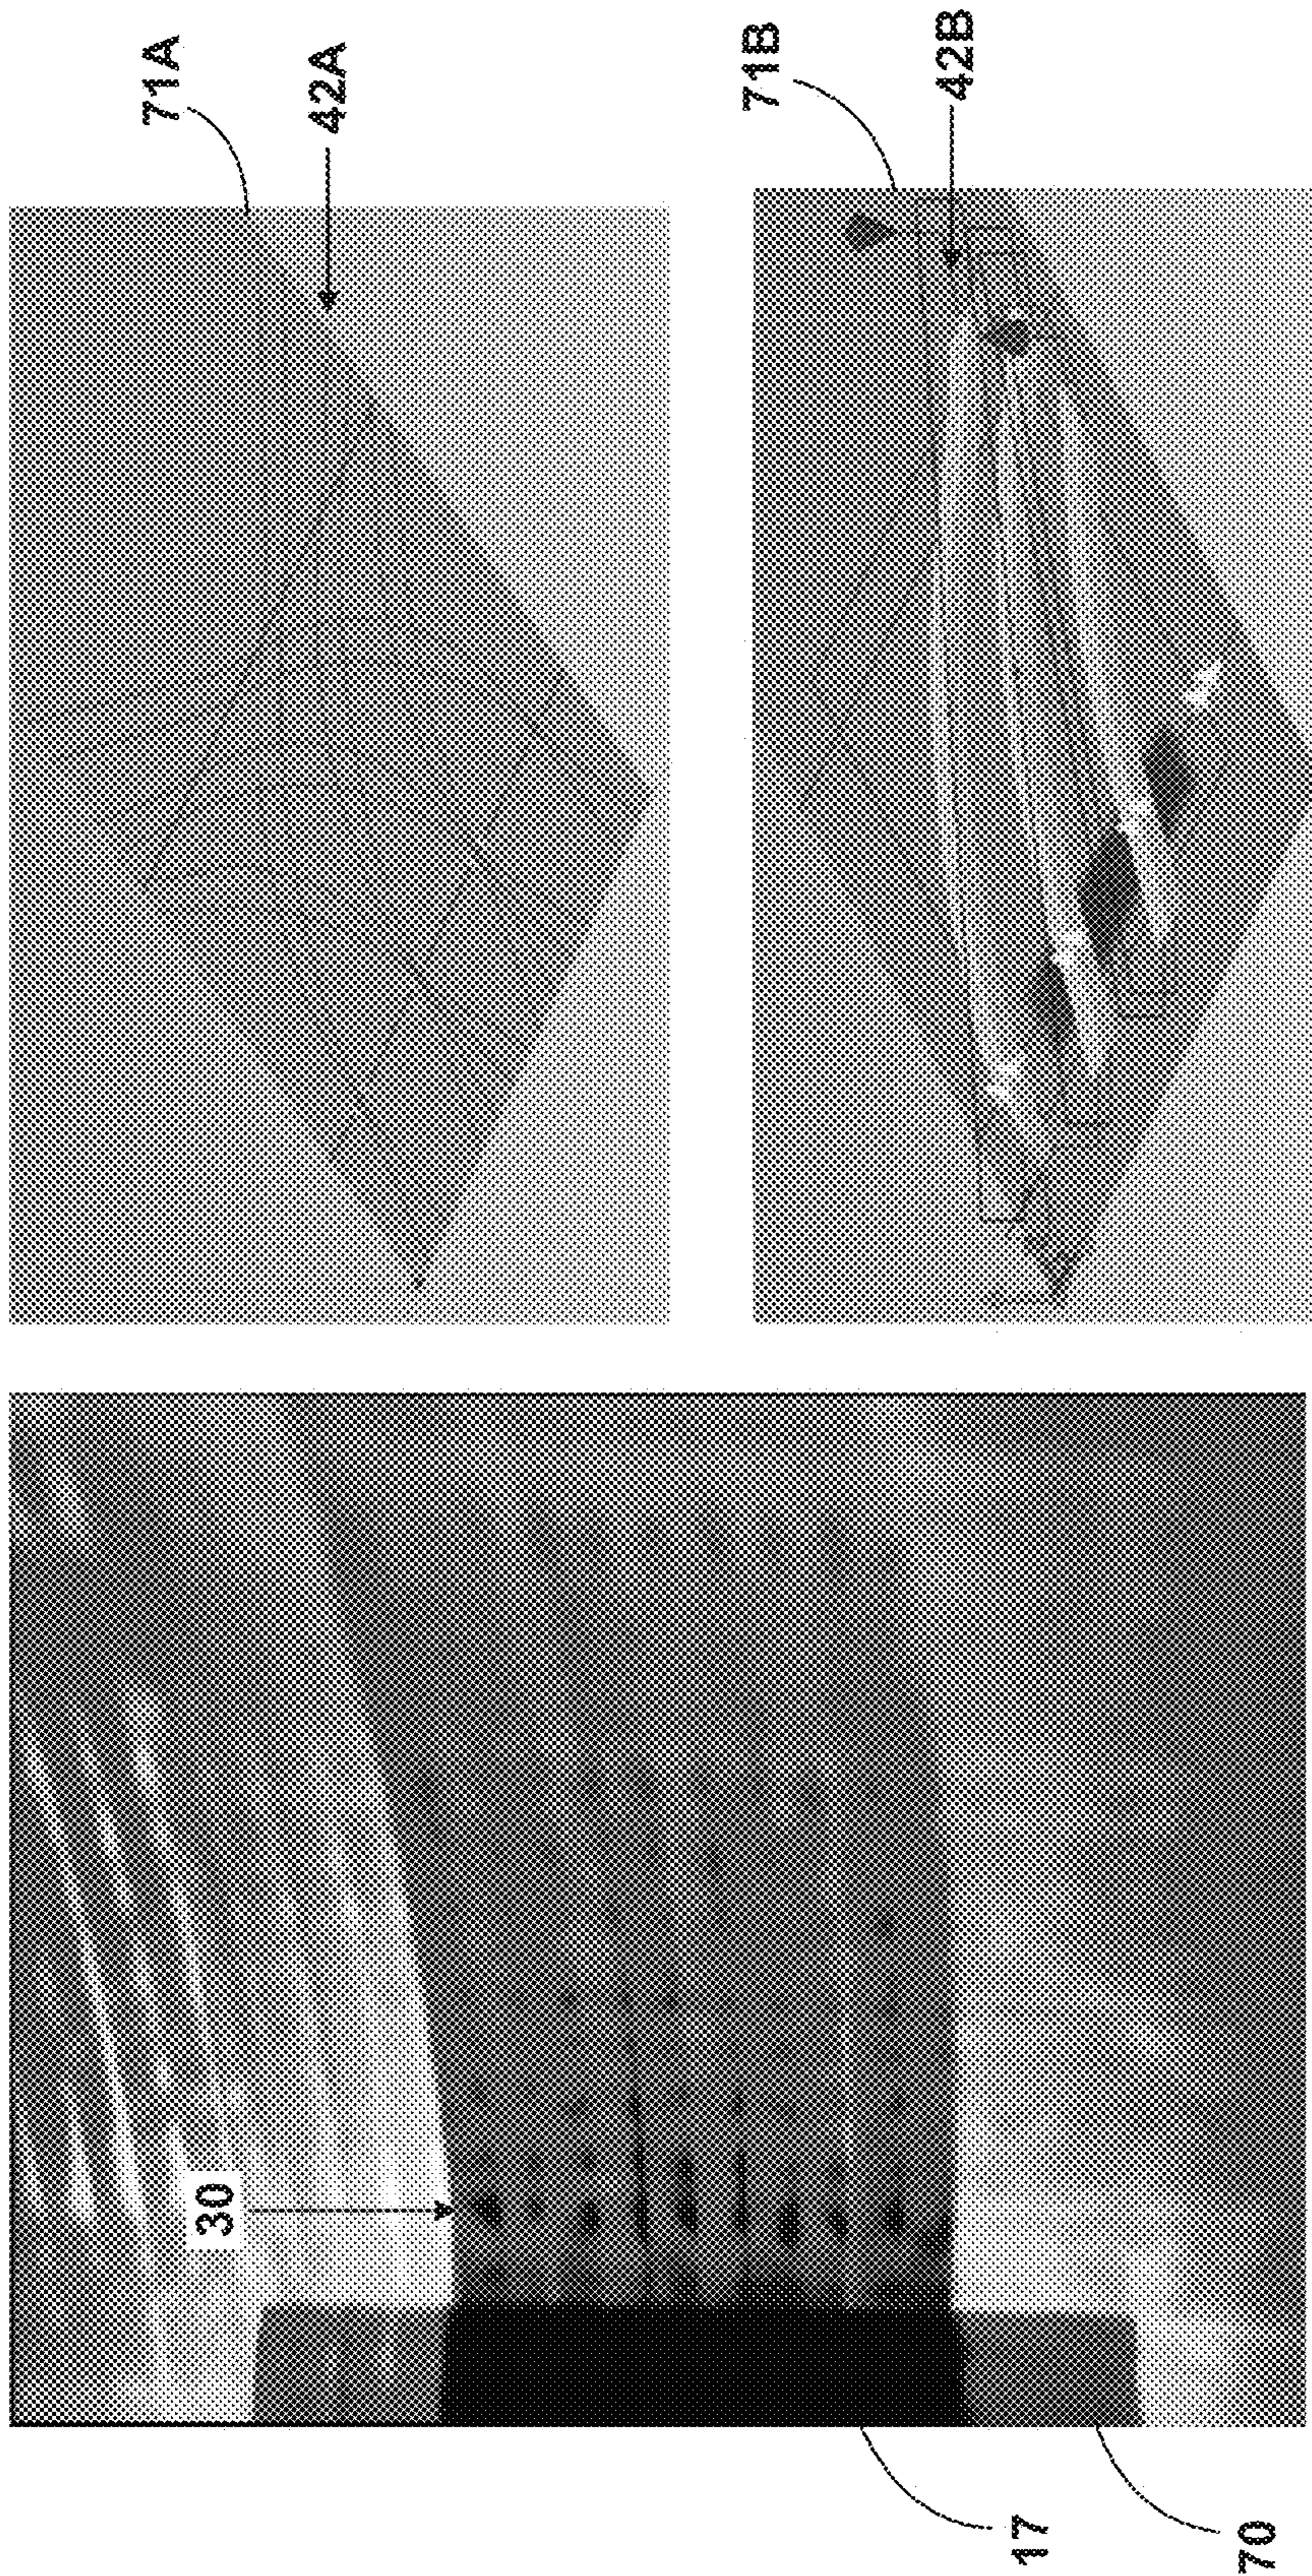
FIG. 7 is a thermographic image of a tow being applied to a heated substrate, and computer-generated schematic views of material courses;

The thermal image 70 (FIG. 7) shows a prepreg tow 30 immediately after being applied by compaction roller 17. Images 71A and 71B are computer-generated images showing material courses or paths 42A and 42B utilized to deposit tow 30. As discussed above, controller 24 of AFP system 10 may be programmed to cause the head 15 to travel along a series of predefined paths to create a specific layup as required for particular composite structure.
