(54) **METHOD AND MEANS TO ANALYZE THERMOGRAPHIC DATA ACQUIRED DURING AUTOMATED FIBER PLACEMENT**

(71) Applicant: **United States of America as represented by the Administrator of NASA, Washington, DC (US)**

(57) **ABSTRACT**

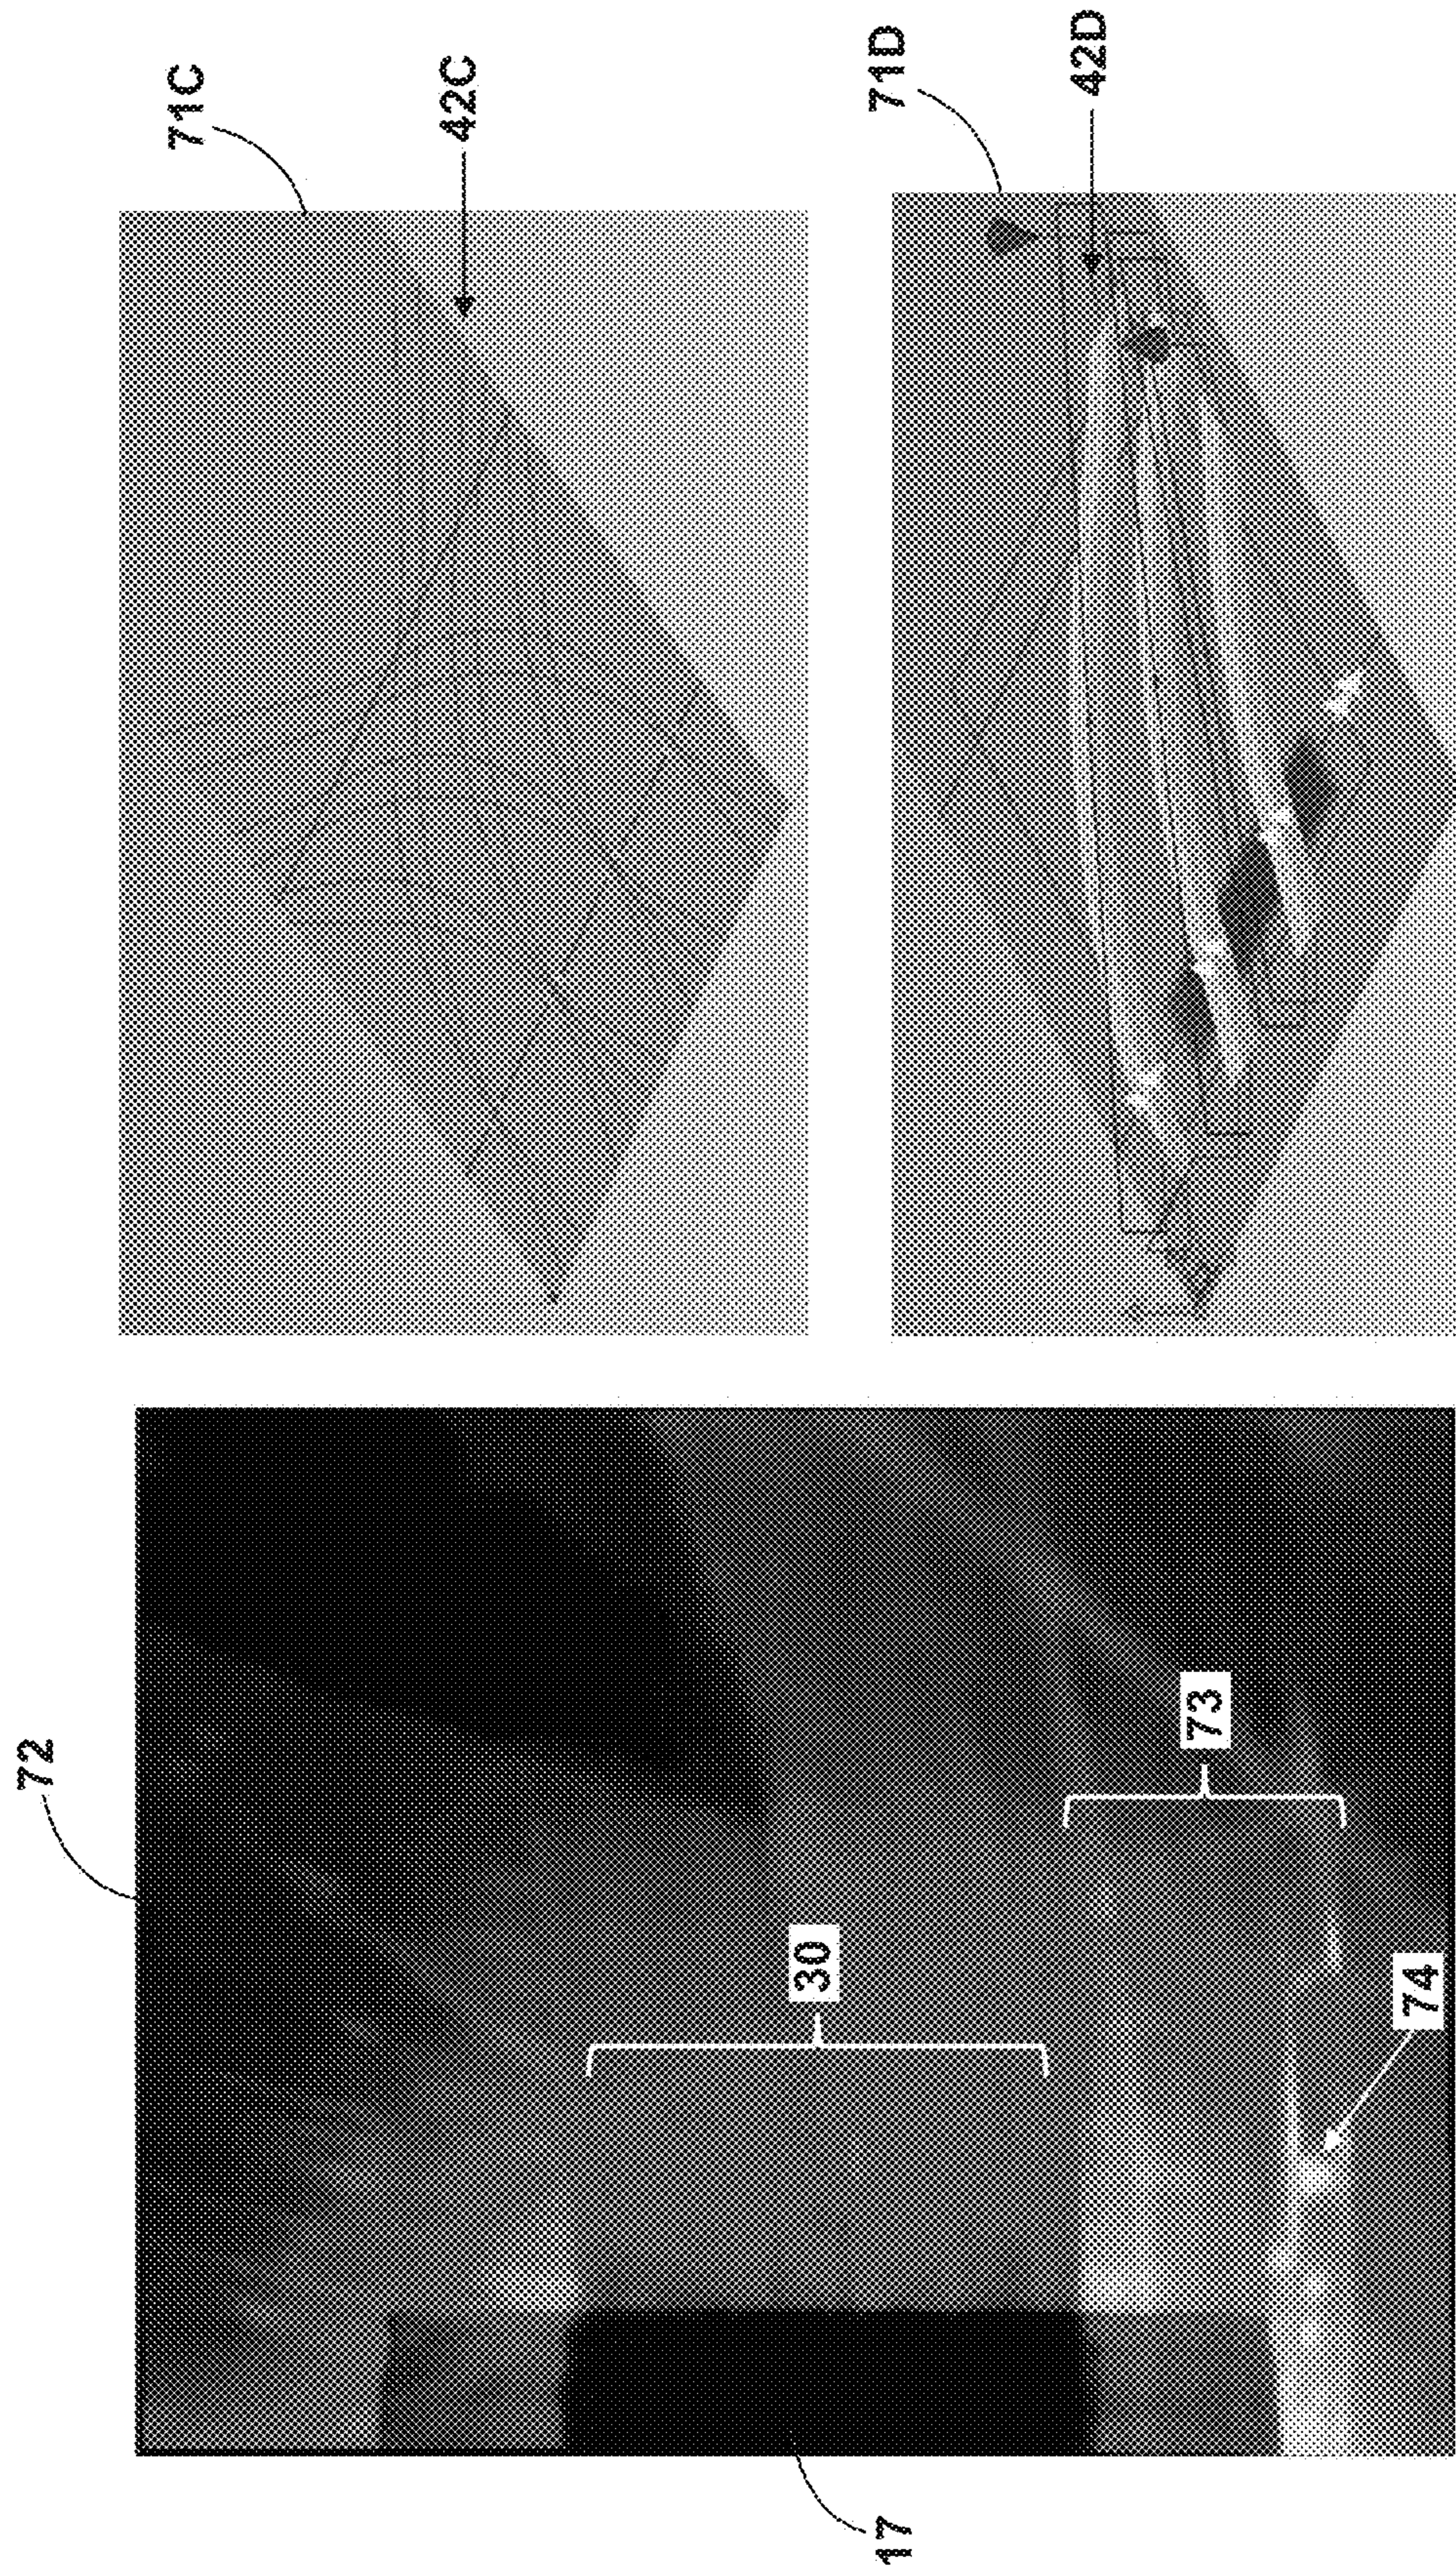
FIG. 8 is a thermographic image of a tow being applied to a heated substrate, and a computer-generated schematic view of material courses;

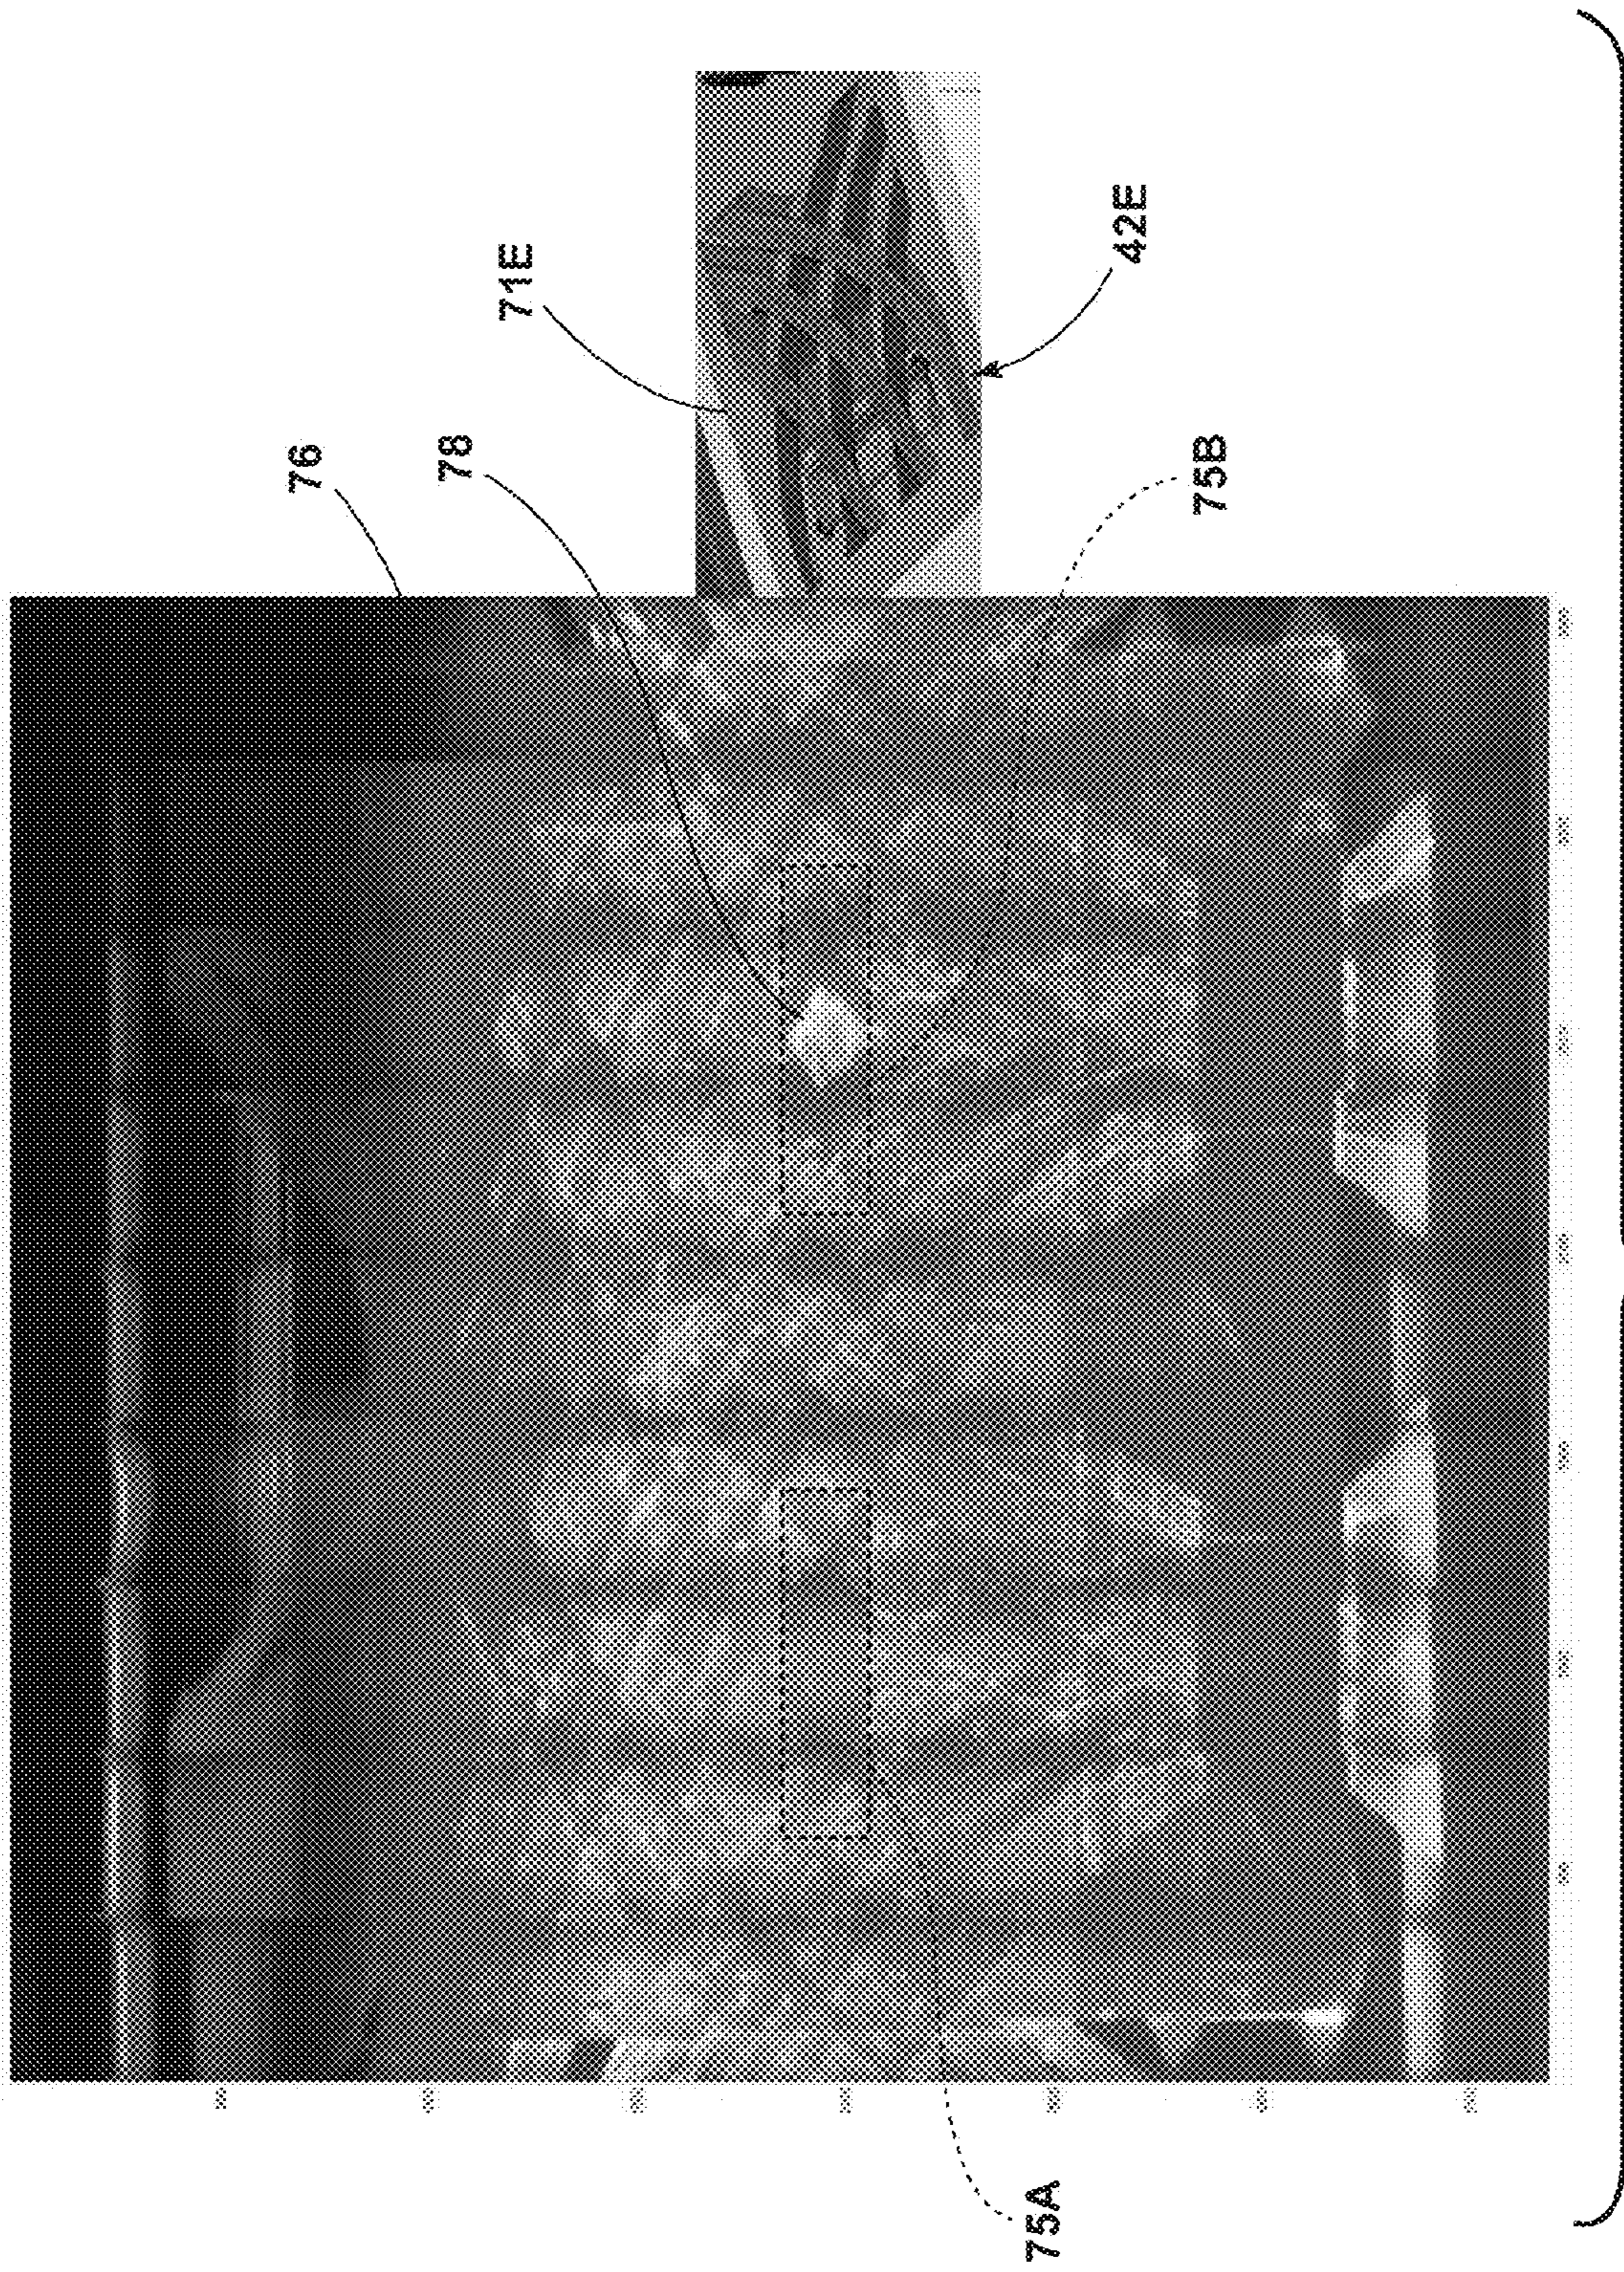
FIG. 9 is a temporally aligned (composite) image generally using a line scan process of a region of a composite structure prior to a debulk process;

material was laid over it. The pressure and direction of roller 17 may cause the composite material to “bunch up” and disbond. This defect may result in a higher temperature region 78. The thermal image 76 generally corresponds to a tow path 42E of computer-generated image 71E.

The differences between the thermal images 76 and 80 of FIGS. 9 and 10 indicate that the debulking cycle significantly reduced the areas with poor adhesion. More specifically, the reduction in yellow “hot spots” in FIG. 10 show that regions of reduced heat transfer due to poor adhesion between plies were significantly reduced by the debulking process. The image data may be aligned utilizing a manual or automated process to combine all or part of individual images to make a composite image of the larger whole. In this way, individual images may be aligned in space and time. As noted above, FIG. 9 shows the panel after the final ply layer, prior to debulk, and FIG. 10 shows the panel after a 30 minute debulking cycle. From the temperature differential (or “hotspots”) in images 76 and 80, changes in tow adhesion due to partial or complete tow disbond and liftoff can be inferred/detected. A comparison between images 76 and 80 implies that the debulking cycle corrected many of the tow defects, and that many of the tow buckling/liftoff defects that remain are either grouped together or at areas of intersecting geometric features. Areas of intersecting geometric features may comprise locations where plies do not cover the entire region, and are instead made up of small patches or tow steered courses or strips.

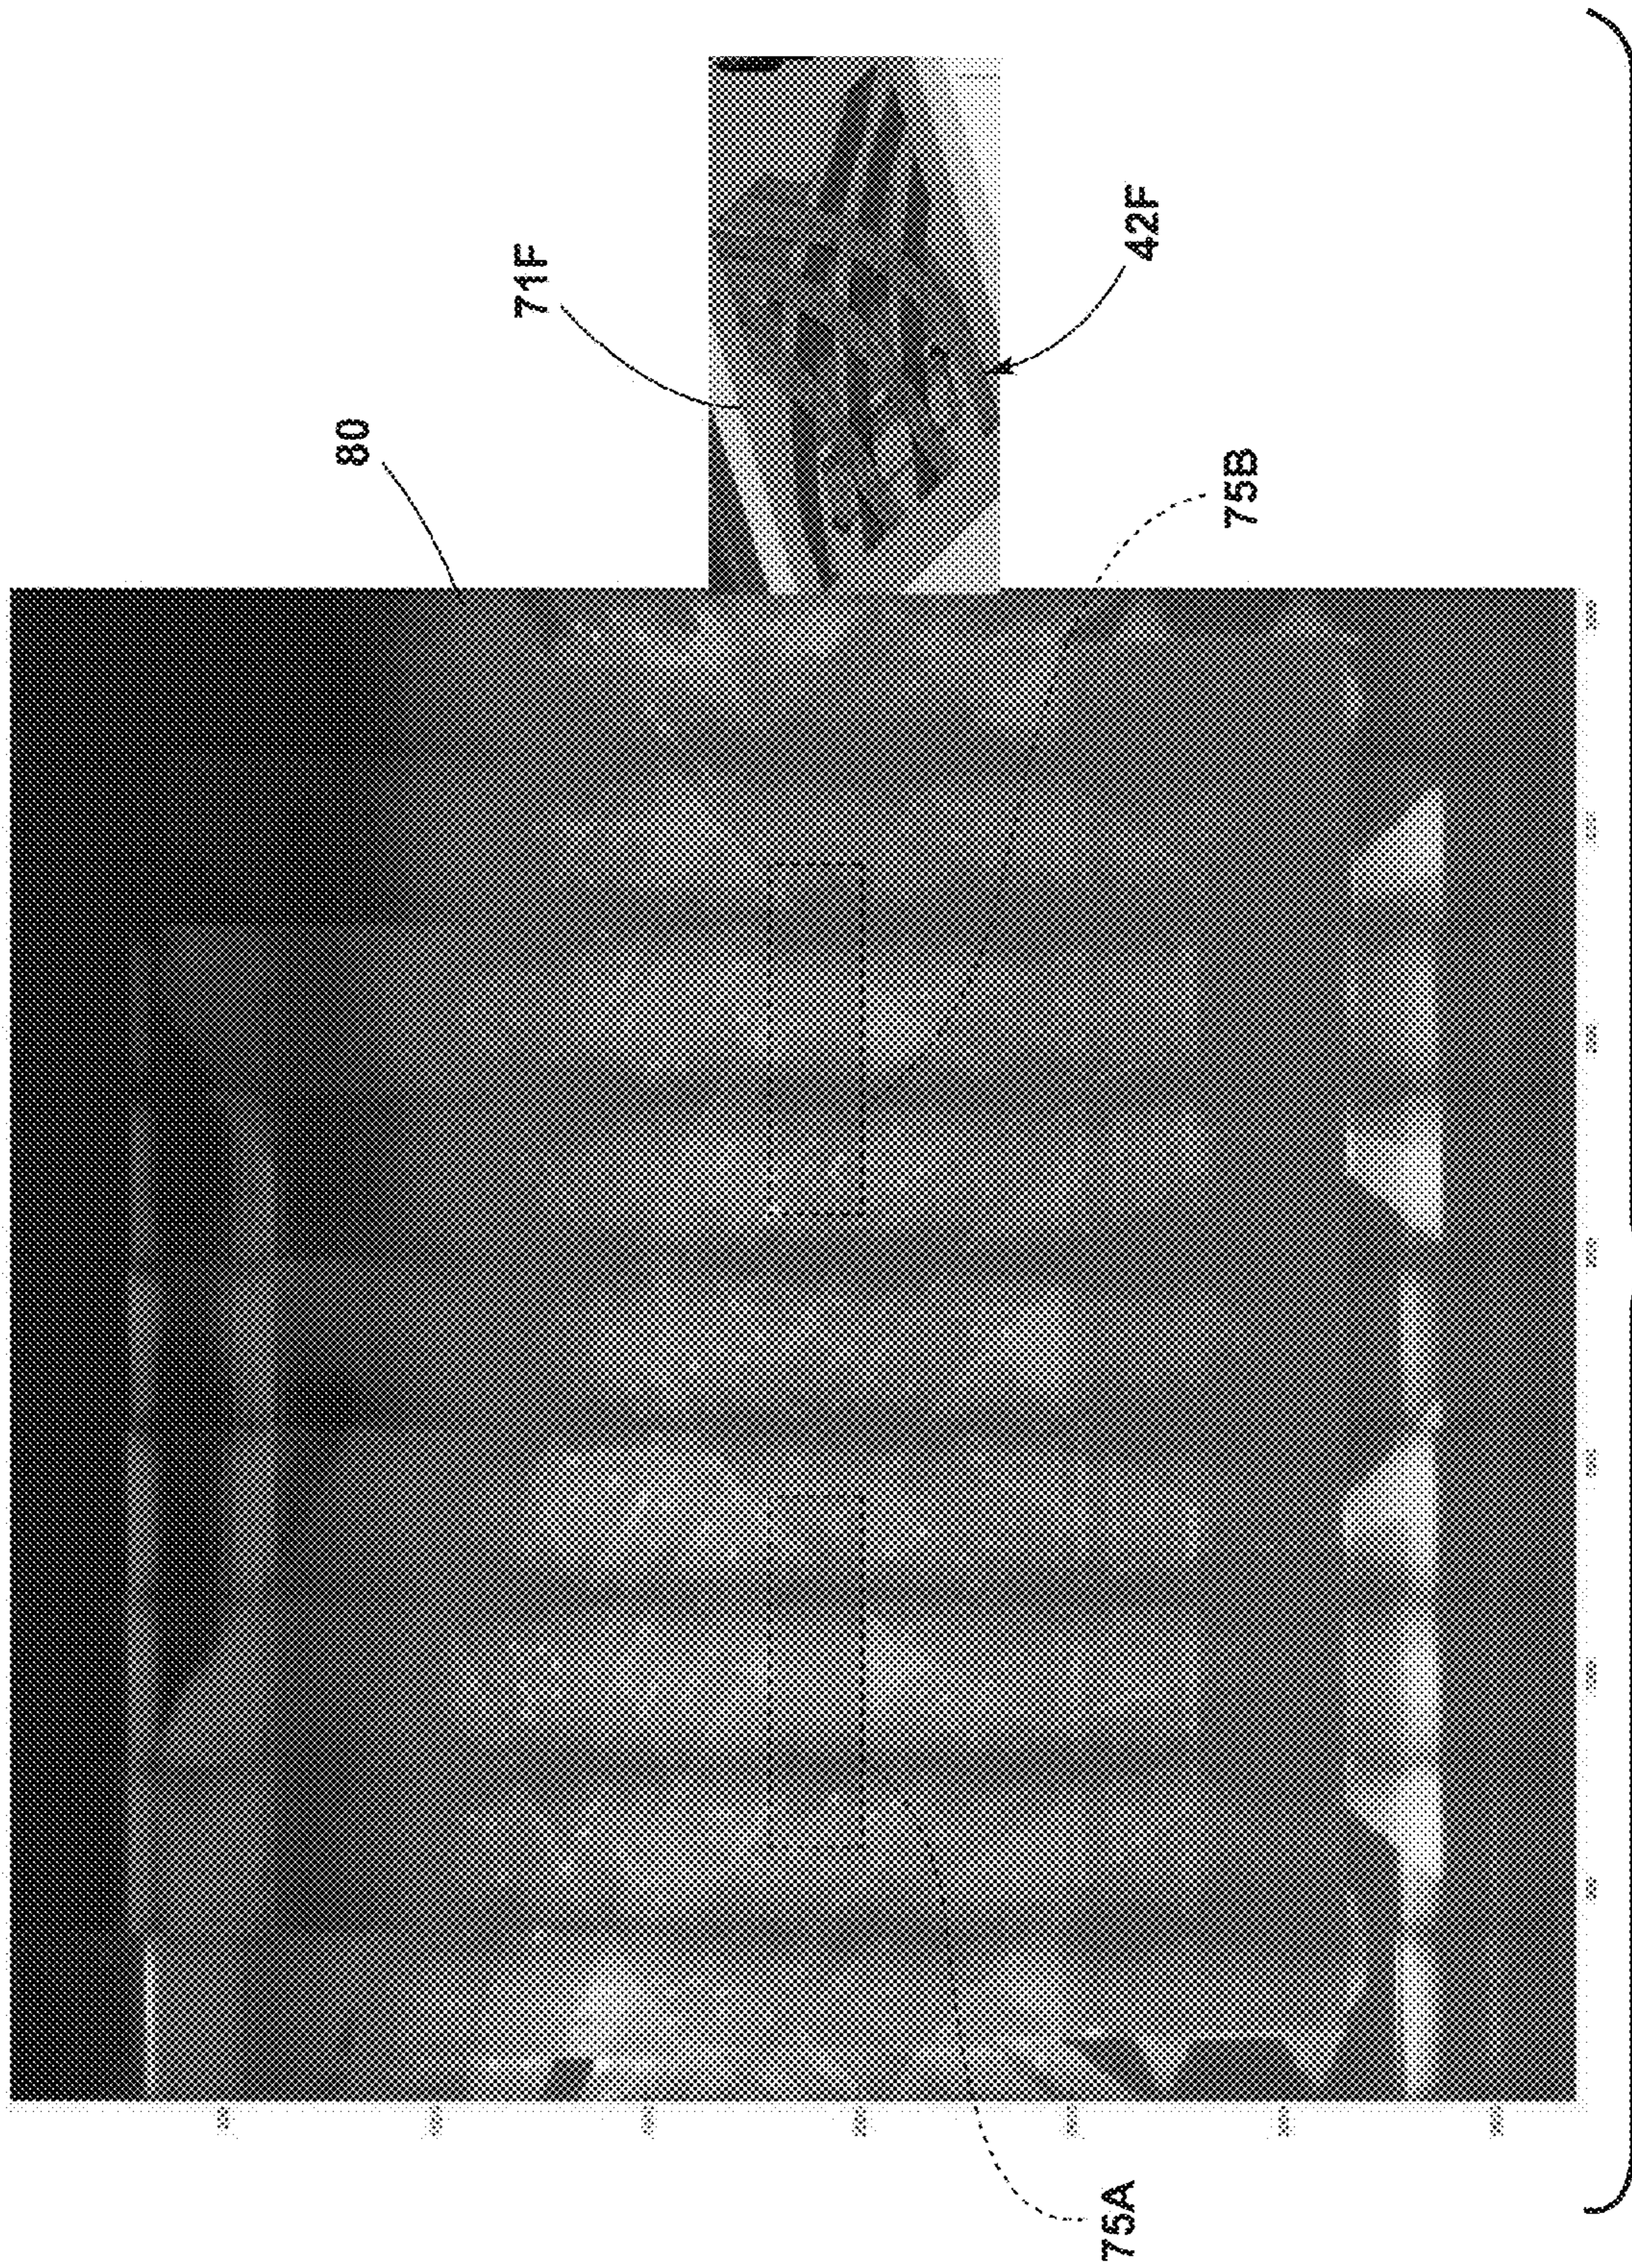
FIG. 10 is a temporally aligned (composite) image generally using a line scan process showing the same region as FIG. 9 after a debulk process;

With reference to FIG. 10, a thermal image 80 taken after a debulk cycle of the part shown in FIG. 9 corresponds to a path 42F as shown in computer-generated image 71F. The thermal image 80 includes some lighter regions which generally correspond to areas of higher temperature. However, the image 80 does not include bright spots or other variations indicative of defects.

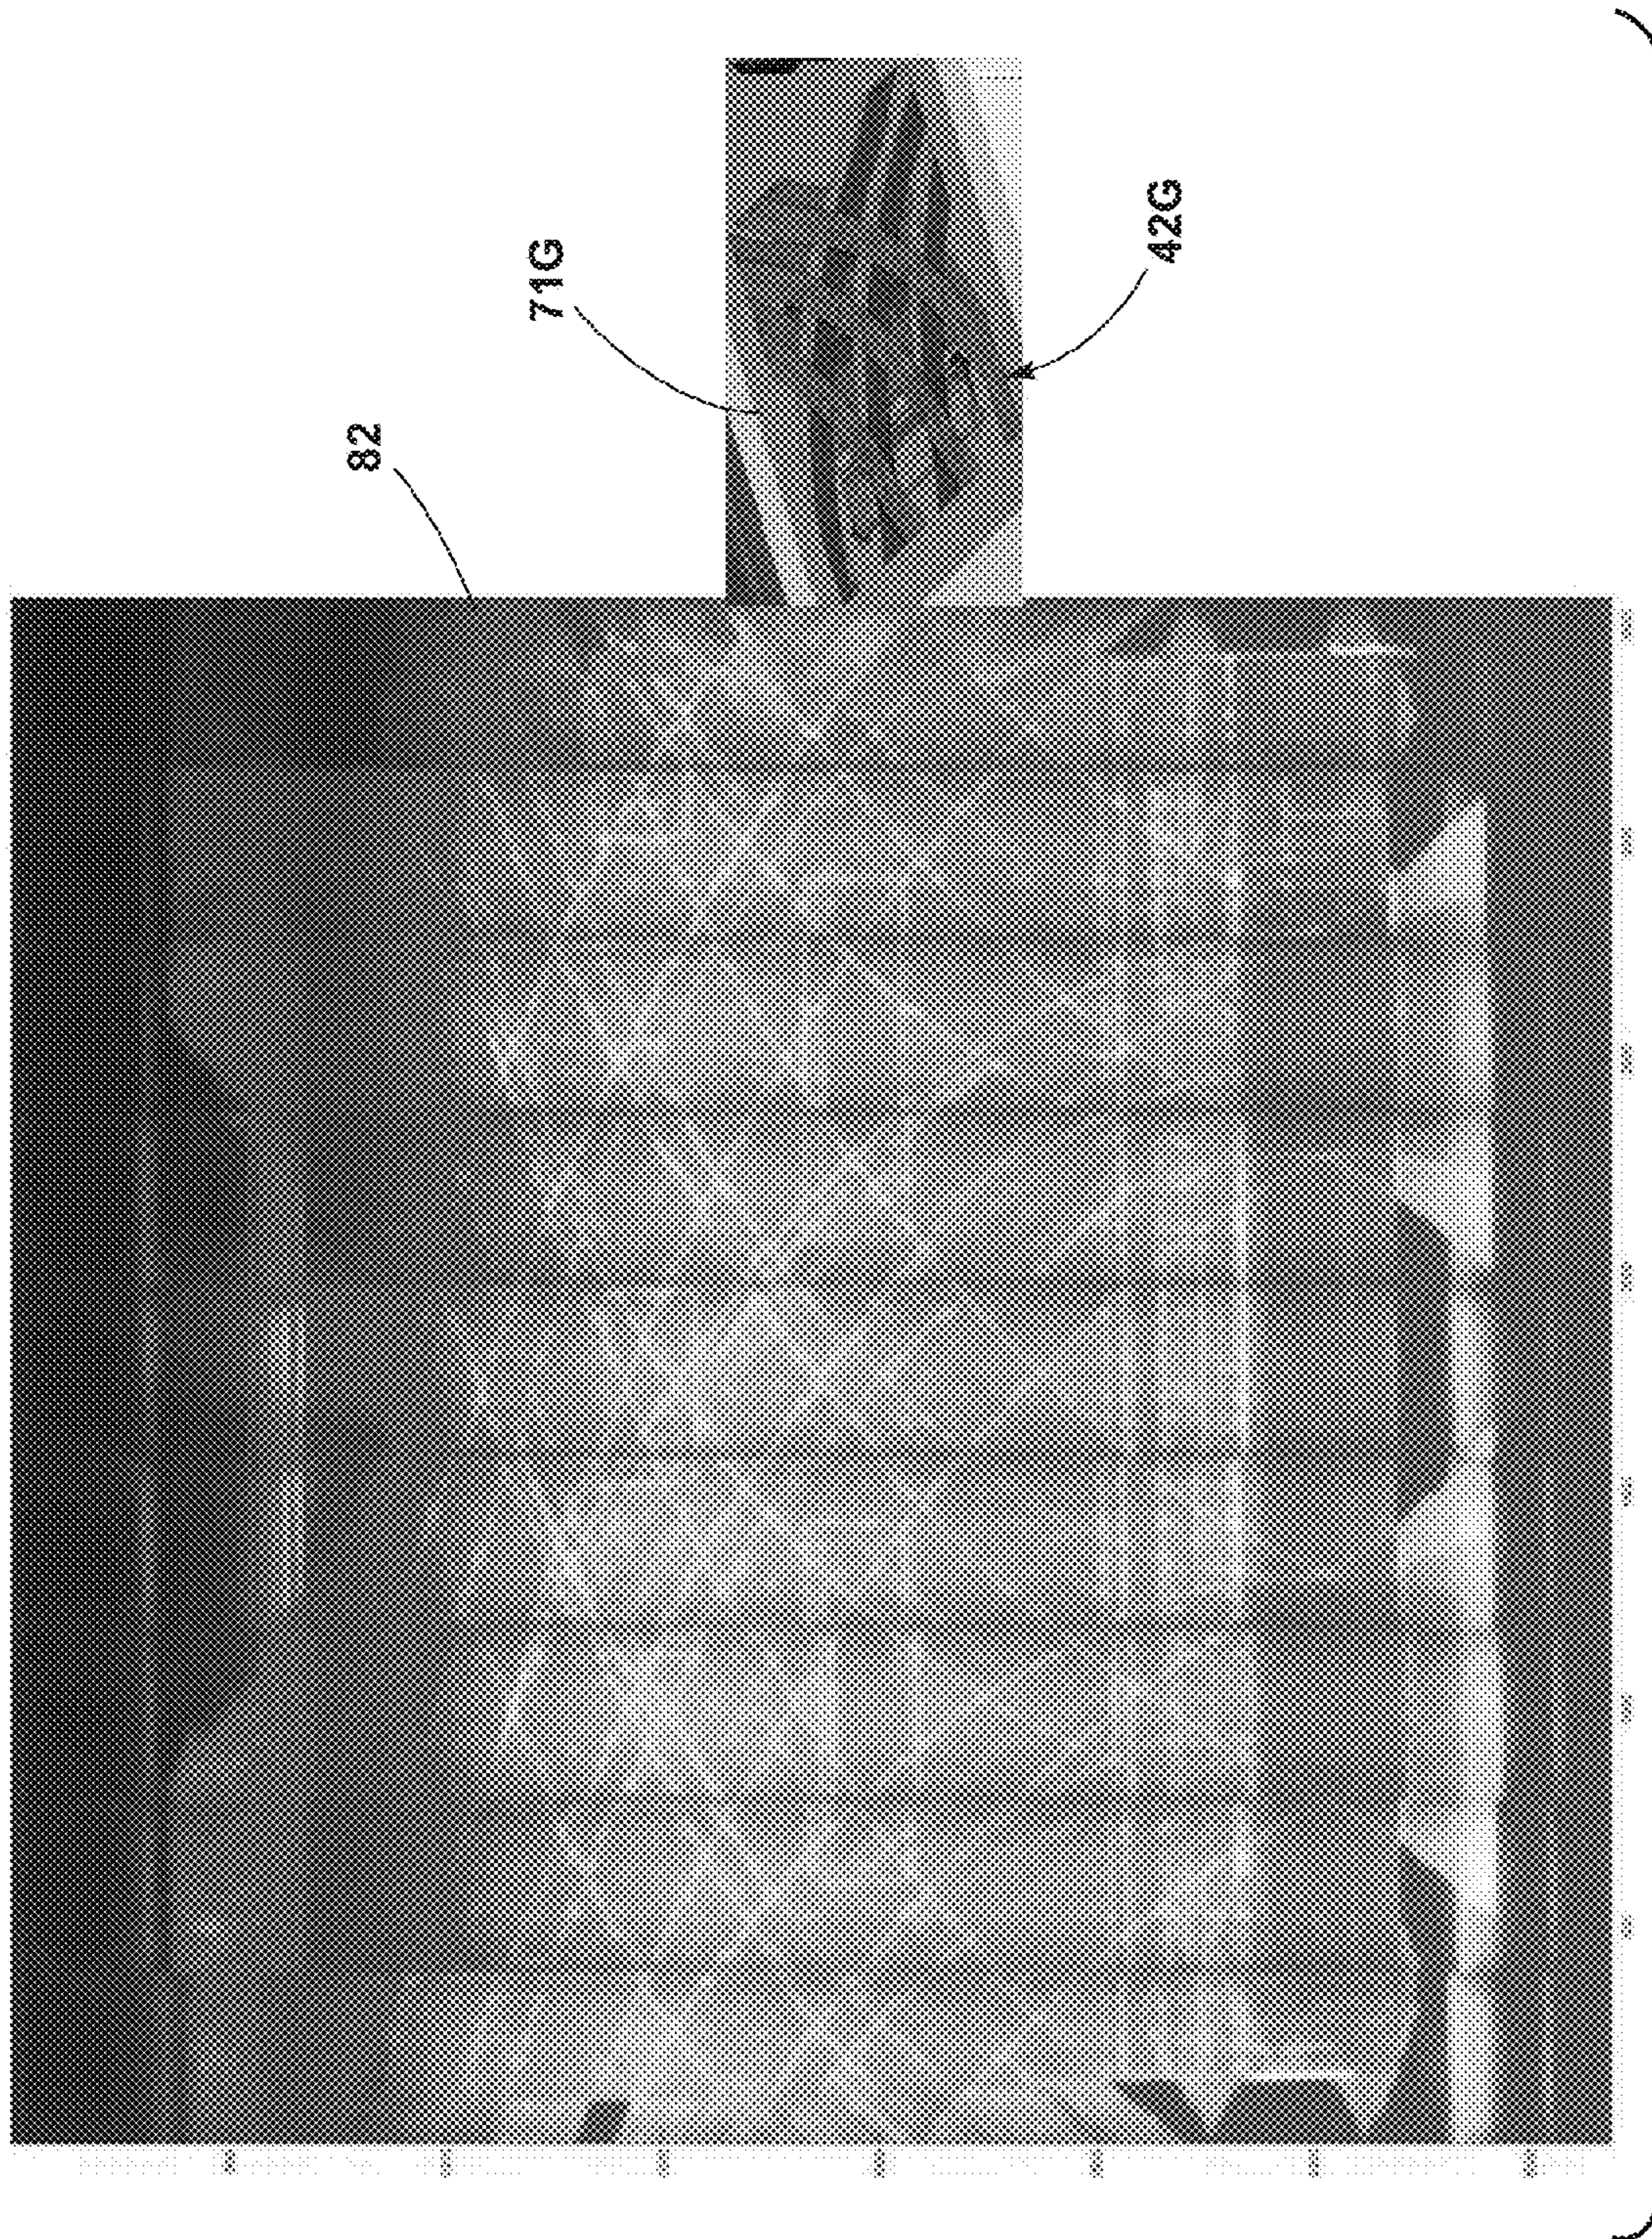
FIG. 11 is a temporally aligned (composite) image of data taken during layup of a final acreage ply, wherein all three images are processed to view a single time step;

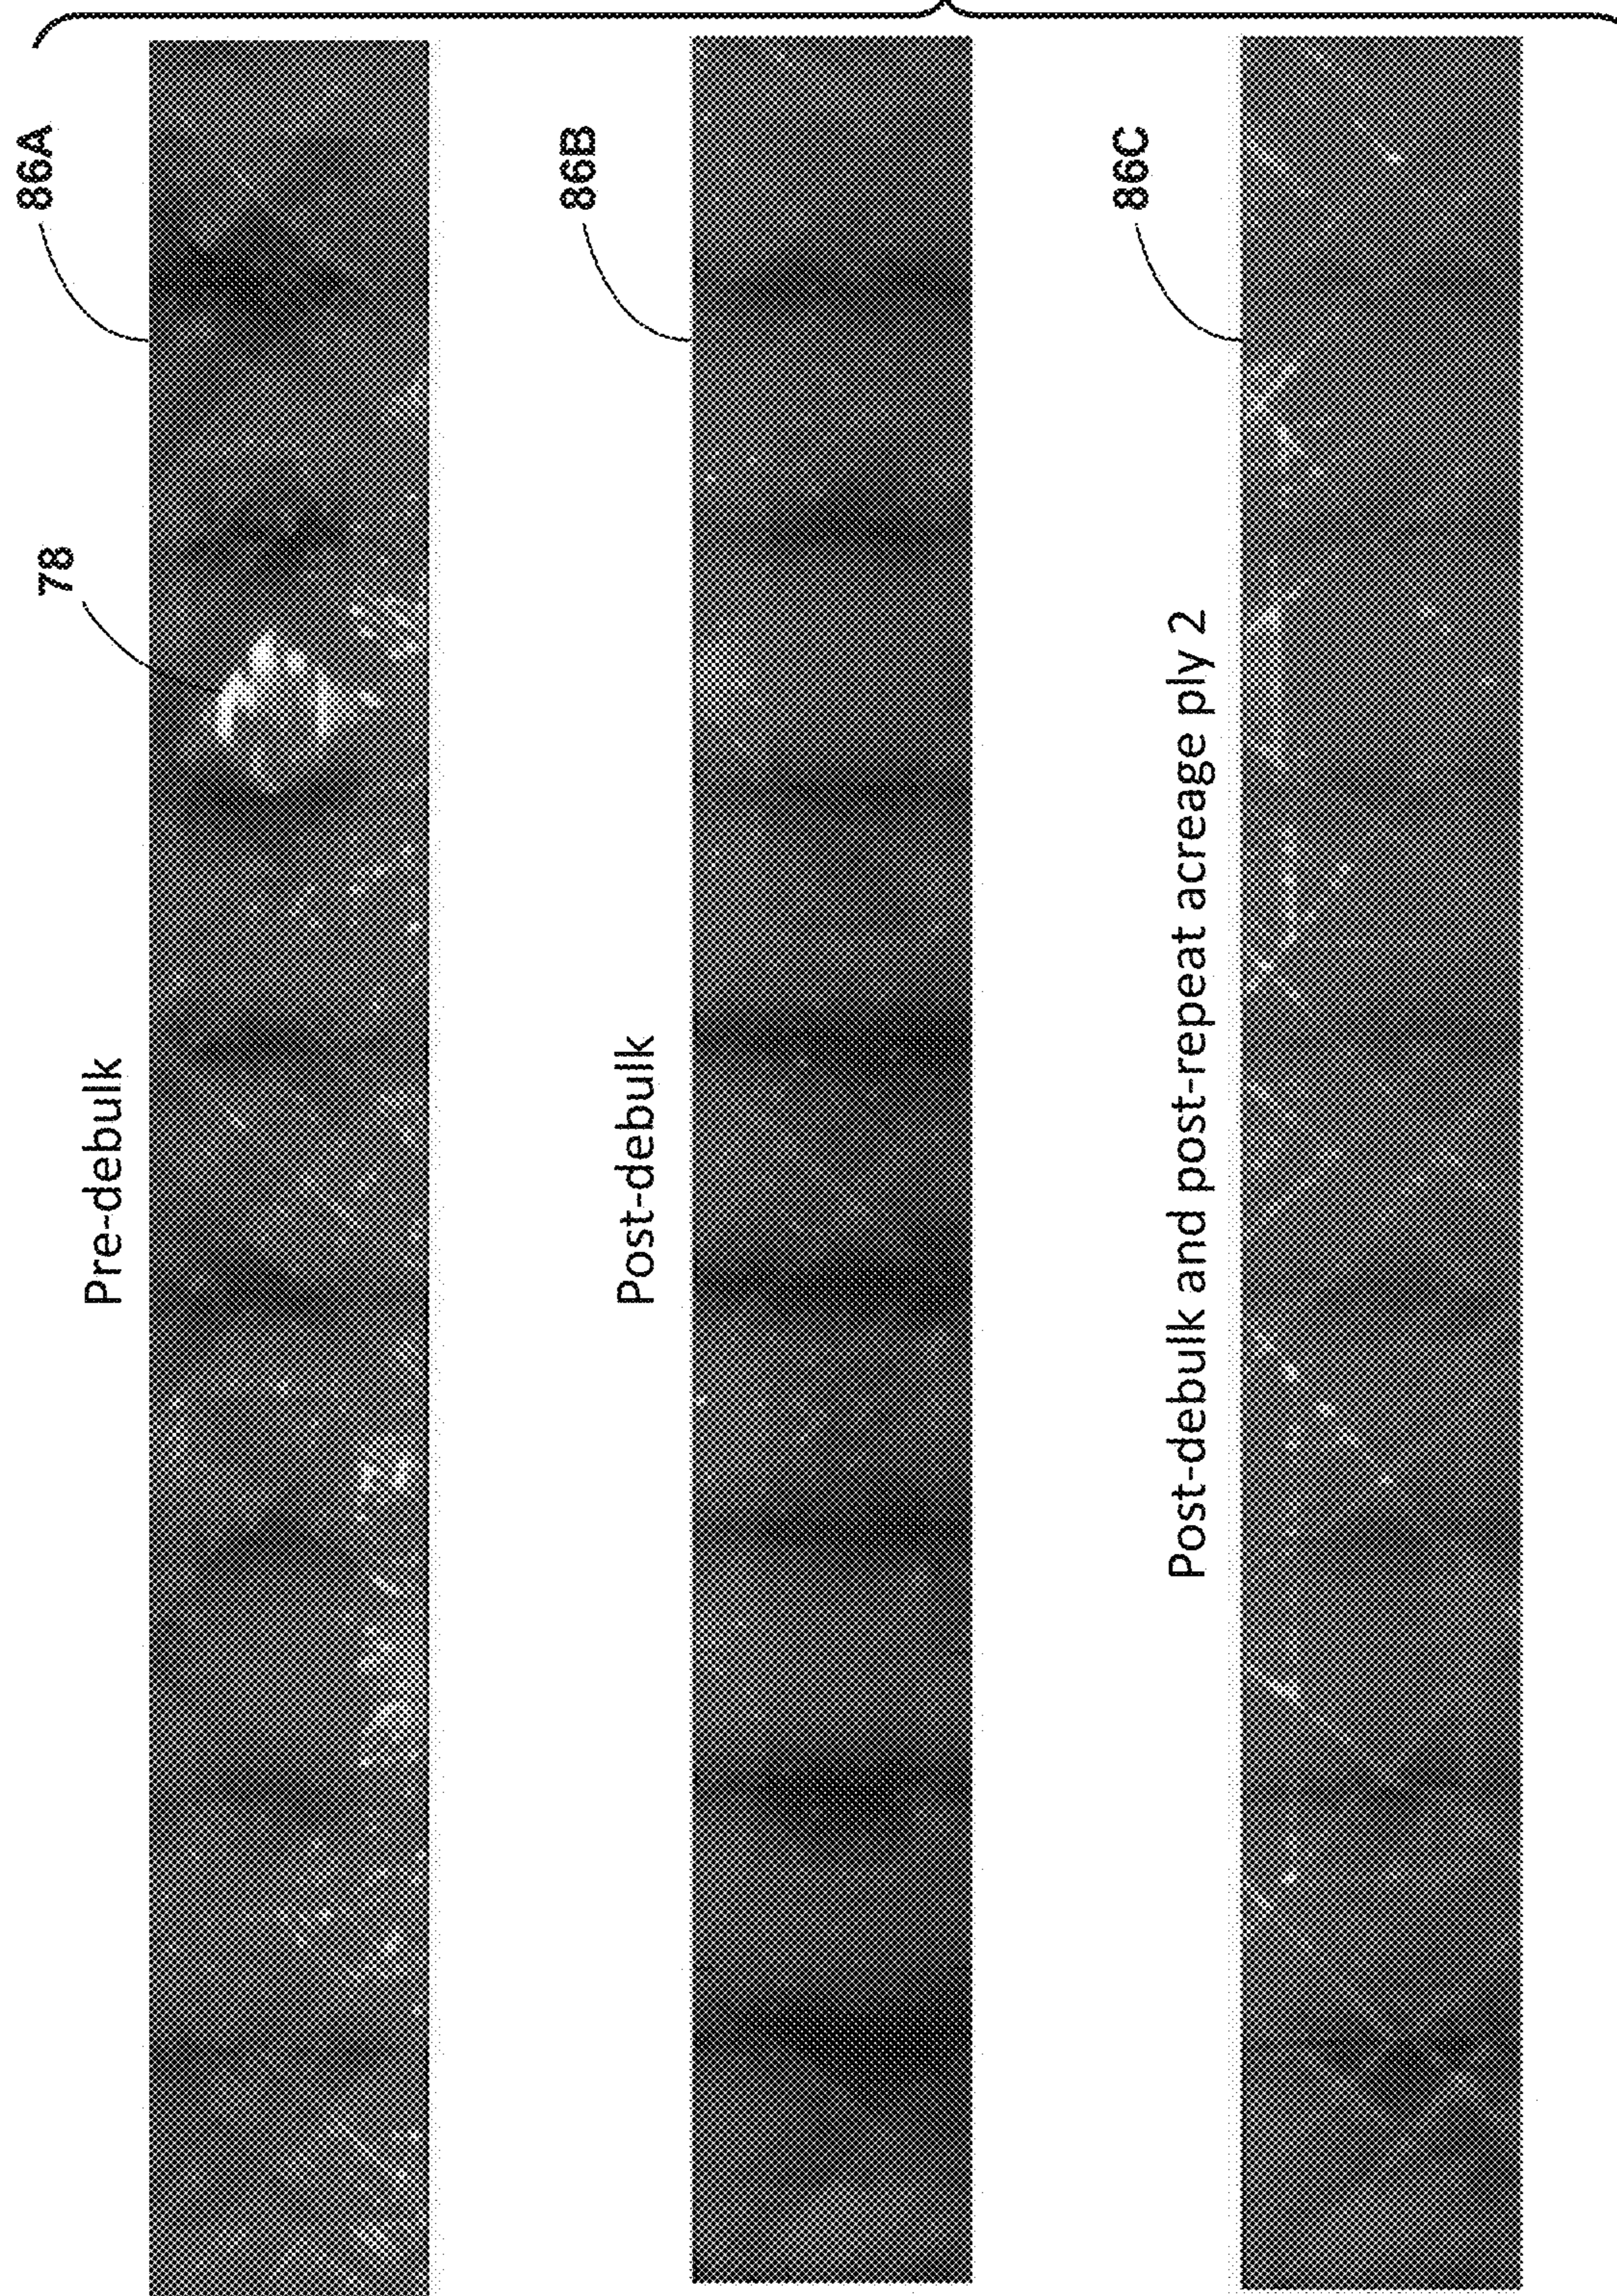
FIG. 13 comprises temporally aligned thermographic image data for a composite structure pre-debulk, post-debulk, and post-repeat acreage ply 2.

With further reference to FIG. 13, a thermal image 86A was generated pre-debulk as prepreg tow was being applied. Thermal image 86B is the same area of a composite structure after a debulk procedure. As discussed above in connection with FIGS. 9 and 10, a bright spot 78 in thermal image 86A corresponds to a region or patch of material that disbonded from the substrate when new material was laid over it. The pressure and direction of the roller 17 may cause it to ‘bunch

up’ and disbond (lose adhesion), resulting in a defect due to poor adhesion. Image 86B shows that the defect was eliminated by the debulking process. Thermal image 86C shows the same surface region of a composite structure post-debulk and post-repeat acreage ply 2. The images show that the debulk cycle reduced the areas of poor adhesion, except in areas where poor adhesion is expected as a result of geometry.
